# Historic Preservation Design Review

February 24, 2011

## HP-11-04, 106 Church St. (City)

<b>Applicant:</b>	John Macloskie for the City of Sumter
<b>Status of the Applicant:</b>	Agent for City Code Enforcement
<b>Request:</b>	Demolition of House in the Hampton Park Historic District
<b>Location:</b>	106 Church St.
<b>Present Use/Zoning:</b>	Vacant Residential/R-6 (Single Family Residential)
<b>Tax Map Reference:</b>	228-12-01-027
<b>Adjacent Property Land Use and Zoning:</b>	North – Residential/R-6/Hampton Park Historic District South – Residential/R-6/Hampton Park Historic District East – Residential/R-6/Hampton Park Historic District West – Residential/R-6/Hampton Park Historic District

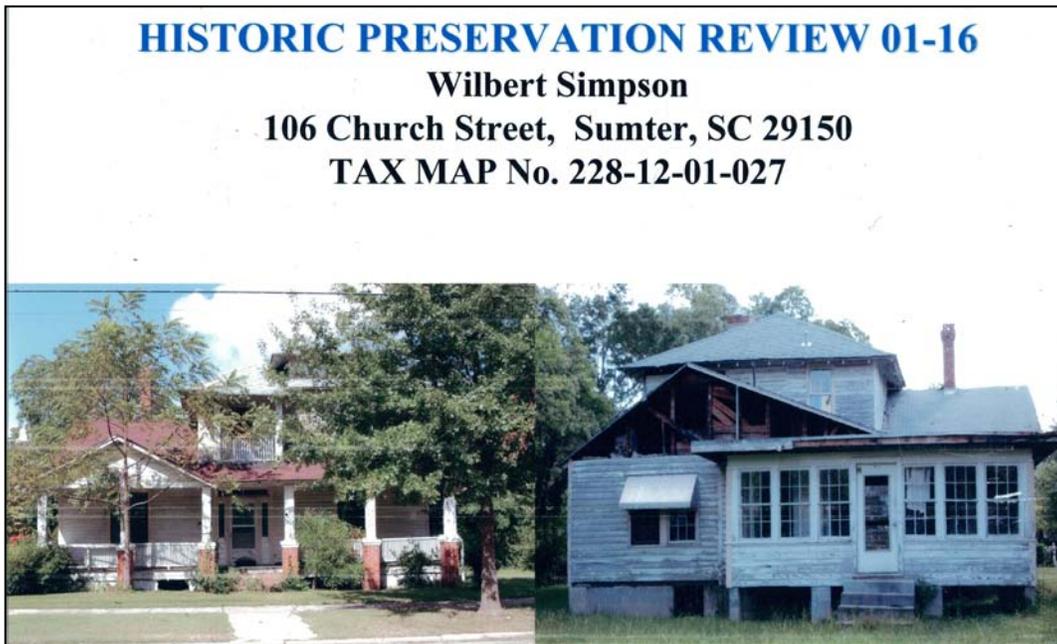
*The front and rear of the structure at the time of the previous  
Historic Preservation Design Review.*

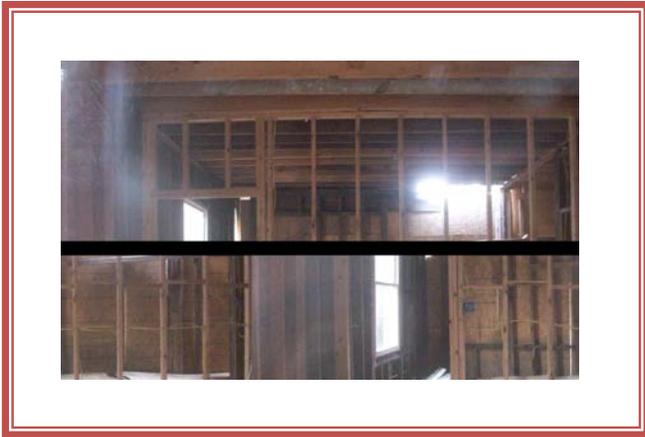
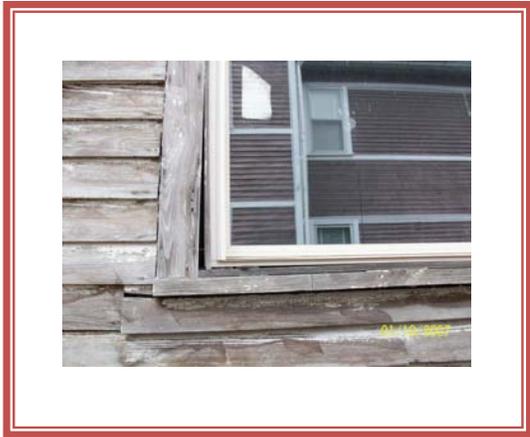
- Shifting of blocks placed to attempt to support the structure in the rear
- Deterioration and crumbling of brick piers
- Buckling and separation of the framing and sill under the front door and all along the attached front porch
- Deteriorated, sagging wall covering along the back where the original rear walls and portions of the structure were removed

- Exterior walls bowing outward along the second story to the rear
- Multiple areas of rot, mold, and vegetative growth in the wood siding, window frames, soffits, and moldings

Staff recommends approval.

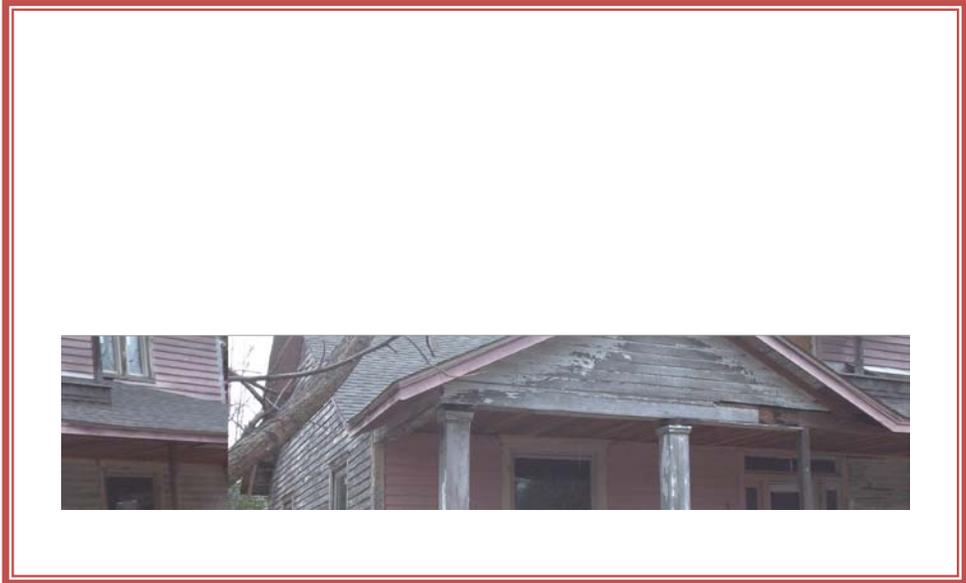
- Separation of brickwork and missing mortar in the uncompleted front steps and porch columns

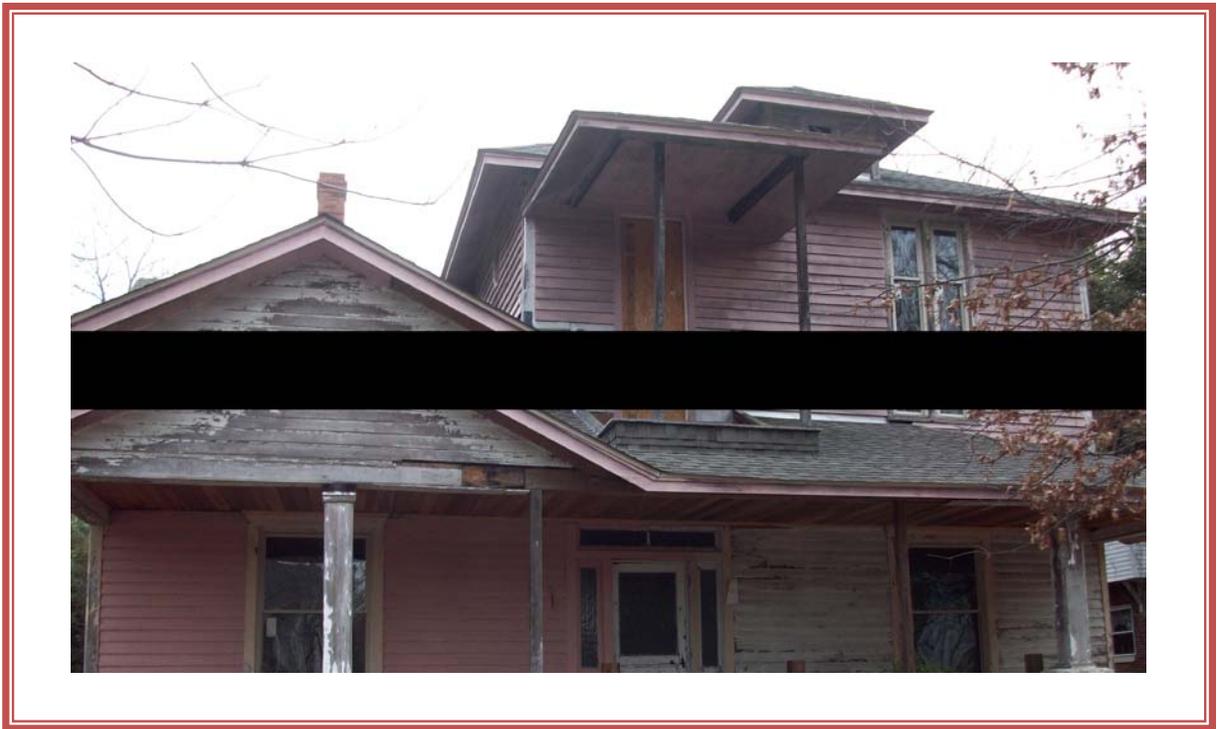
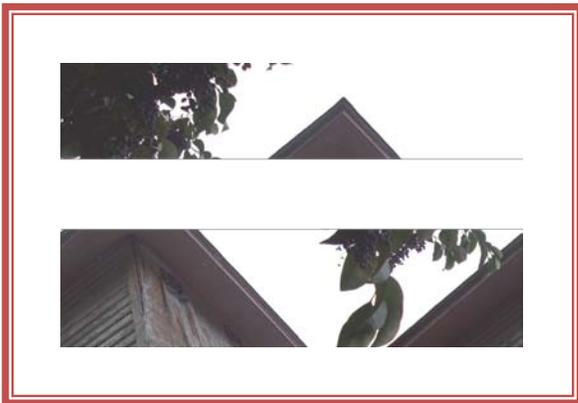
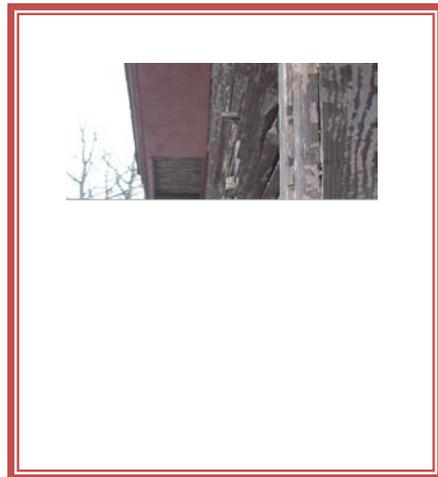
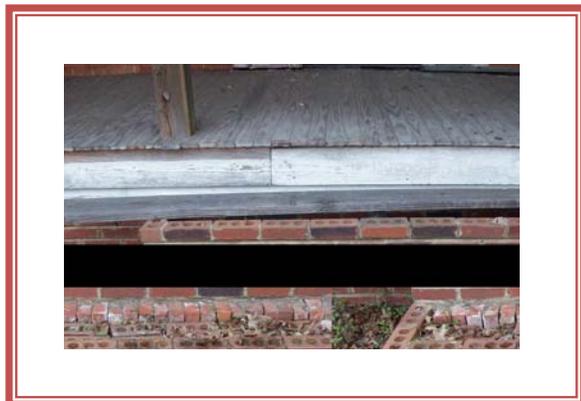
- The interior is gutted and holes in the rear roofline are letting in water, debris, and wildlife
- Vines are growing through visible openings in the floor and walls
