Historic Preservation Design Review

HP-14-14, 21 N. Main St. – Opera House Façade Windows (City)

OPERA HOUSE RENOVATIONS ROOF, CLERESTORY & ASSOCIATED ITEMS

WINDOW REPLACEMENT NARRATIVE:

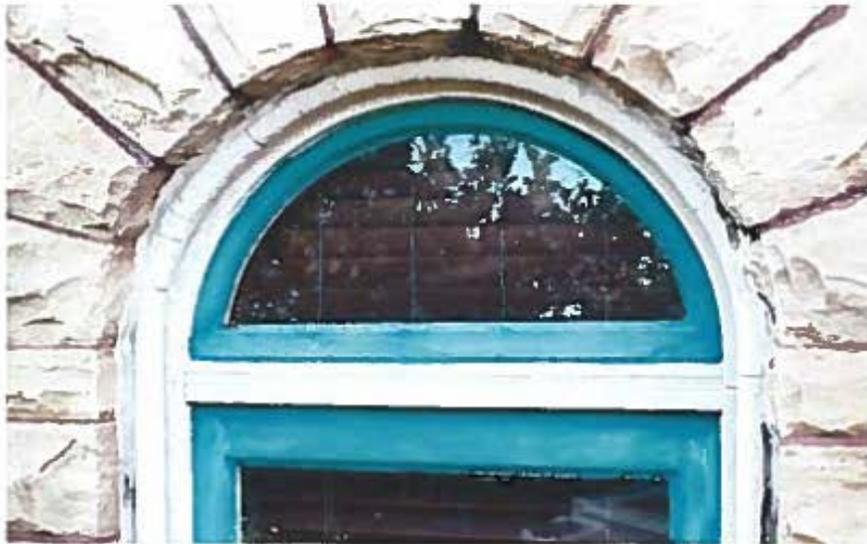
Window W-3F: View of “existing replacement” window with repaired trim rotting again.

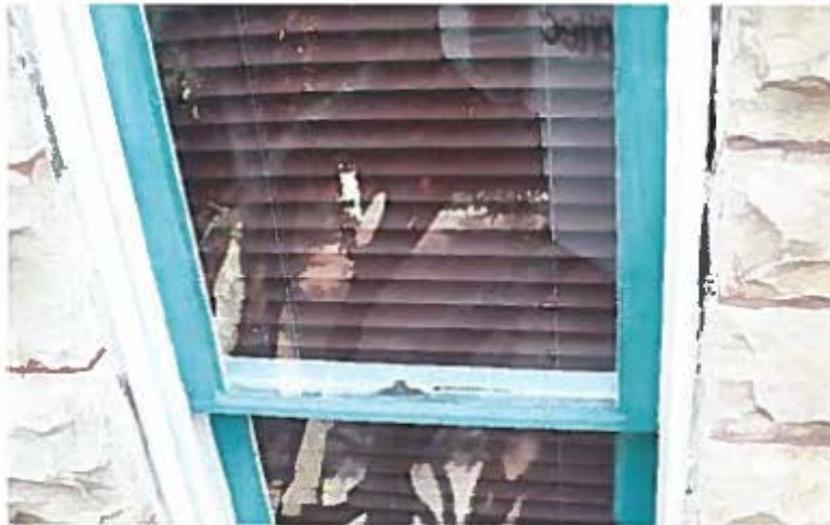
Window W-3F: Exterior wood sash separated. Heavy air flow and sash unlockable.

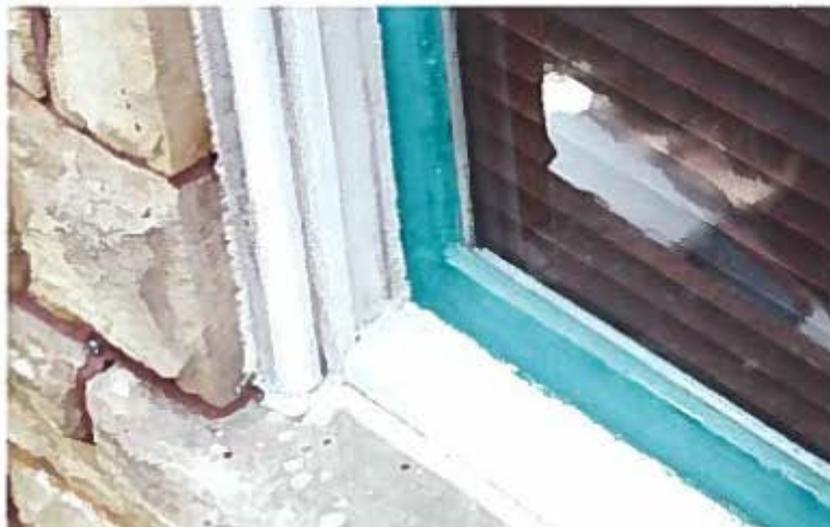
Window W-3F: Rotted exterior wood sill & sash need replacement again.

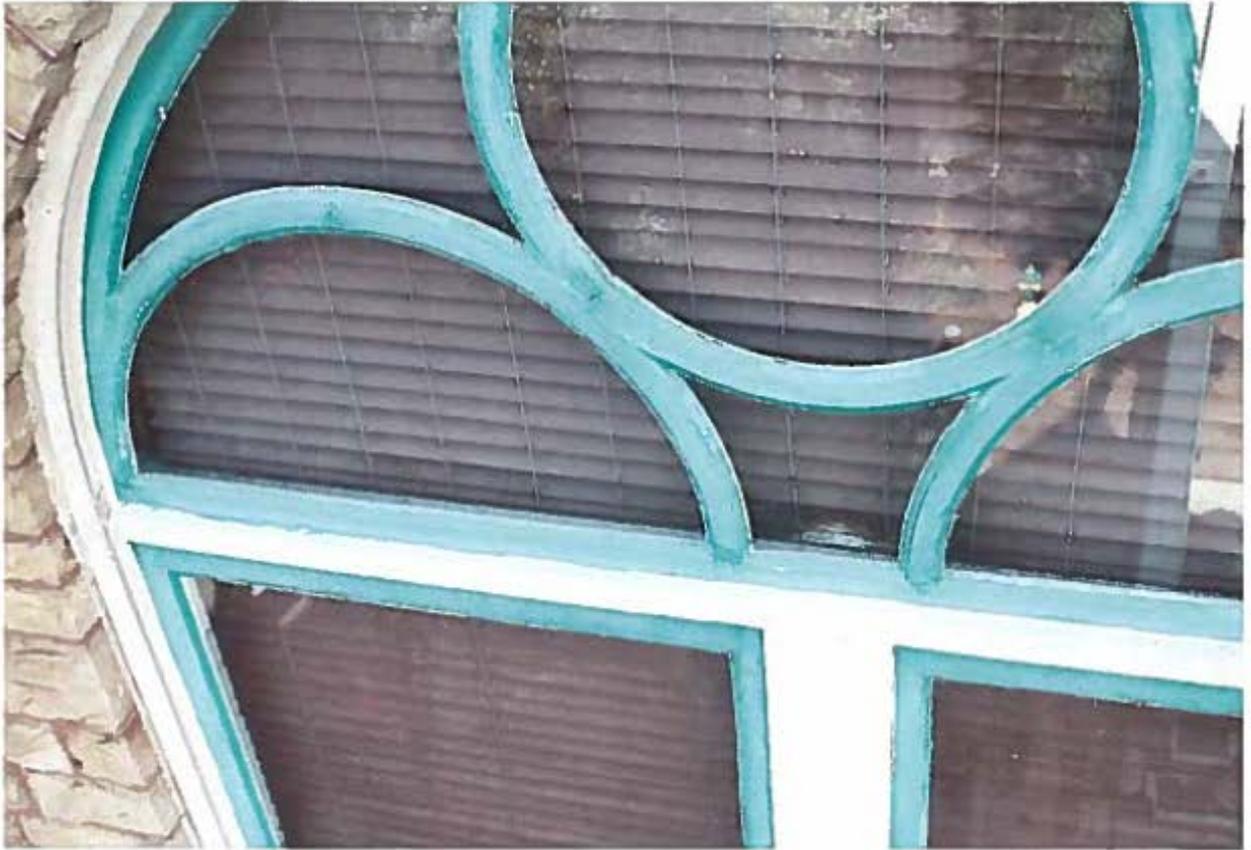
Window W-5D / W-5E: Exterior custom wood header damaged by long term rain & sunlight exposure.

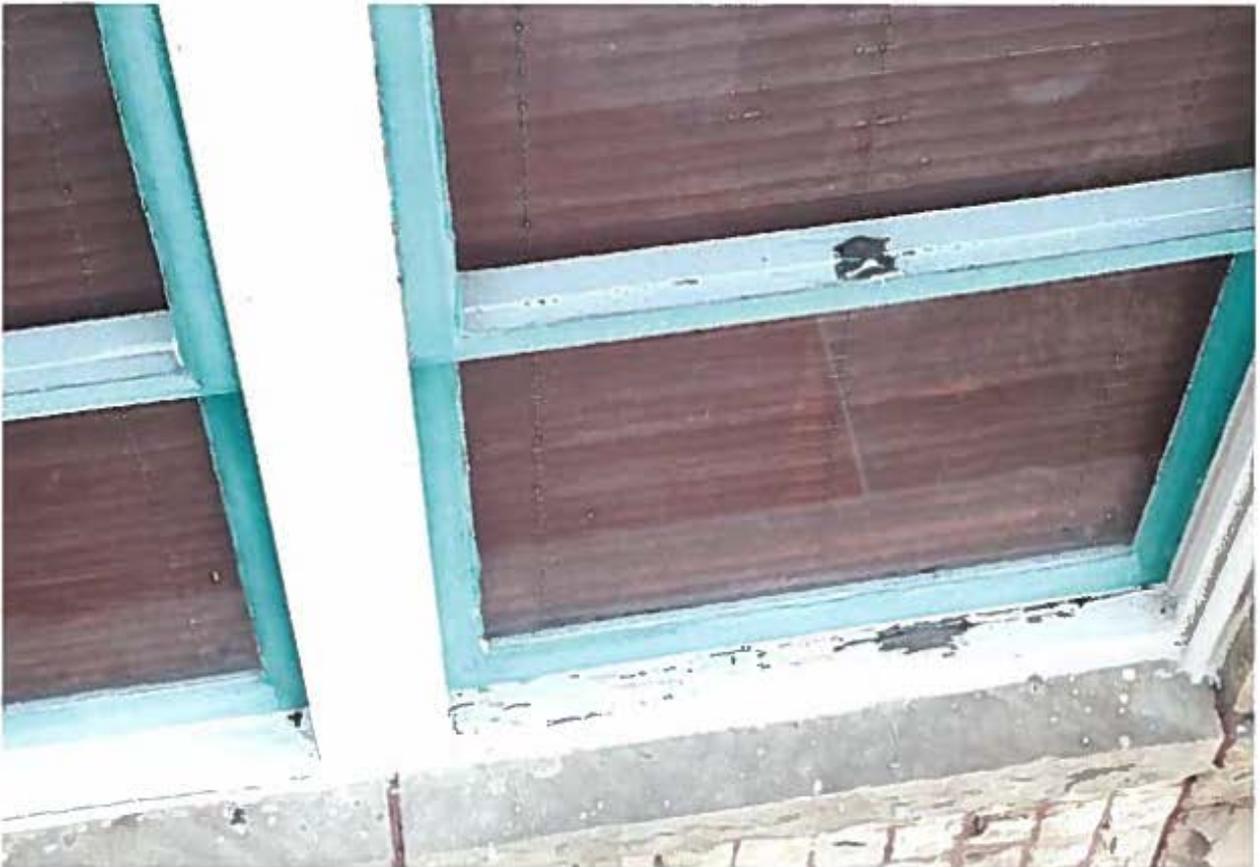
Window W-3D / W-3E: Rotted exterior wood sill damaged by long term rain & sunlight exposure
