**ADDENDUM #1 – June 7, 2013**

**REQUEST FOR PROPOSALS # 01-12/13**

**DEMOLITION PROJECT**

# CITITRENDS BUILDING SQUARE FOOTAGE, PICTURES, AND SUMMARY OF ASBESTOS RESULTS

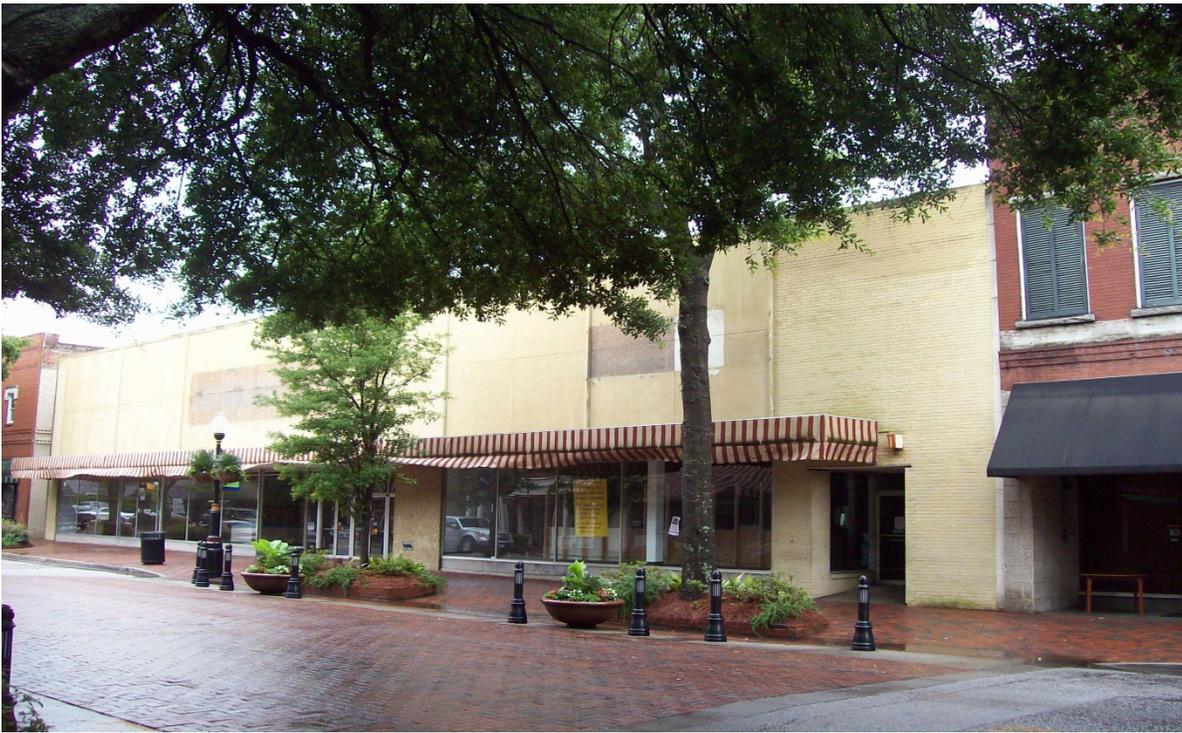
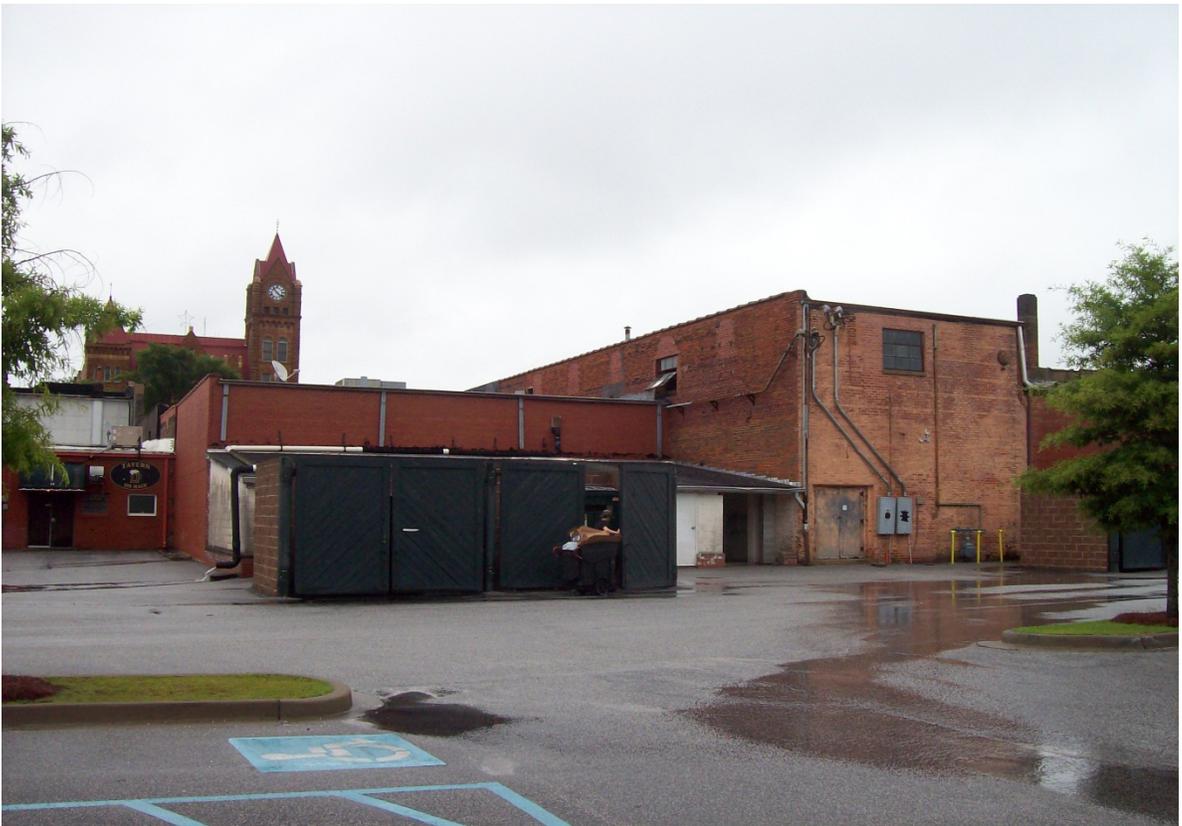
Front & Rear Pictures of Cititrends Building (1-story) measures: 48' x 195'

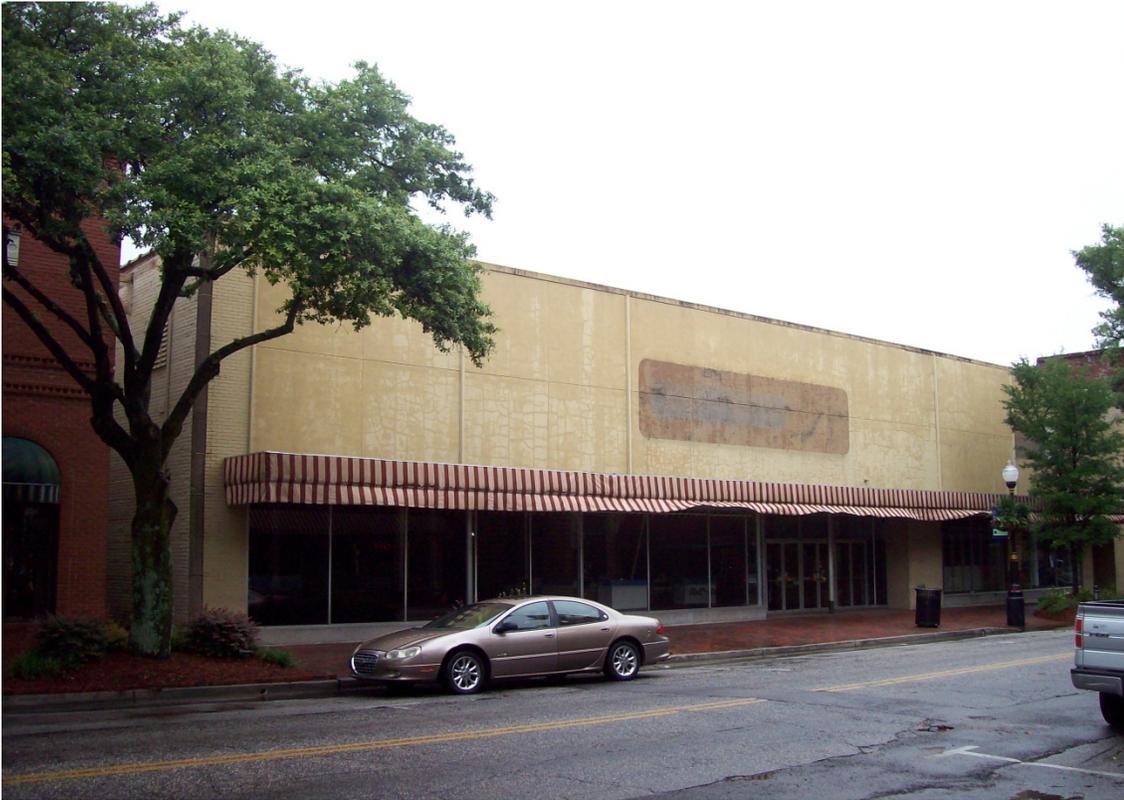
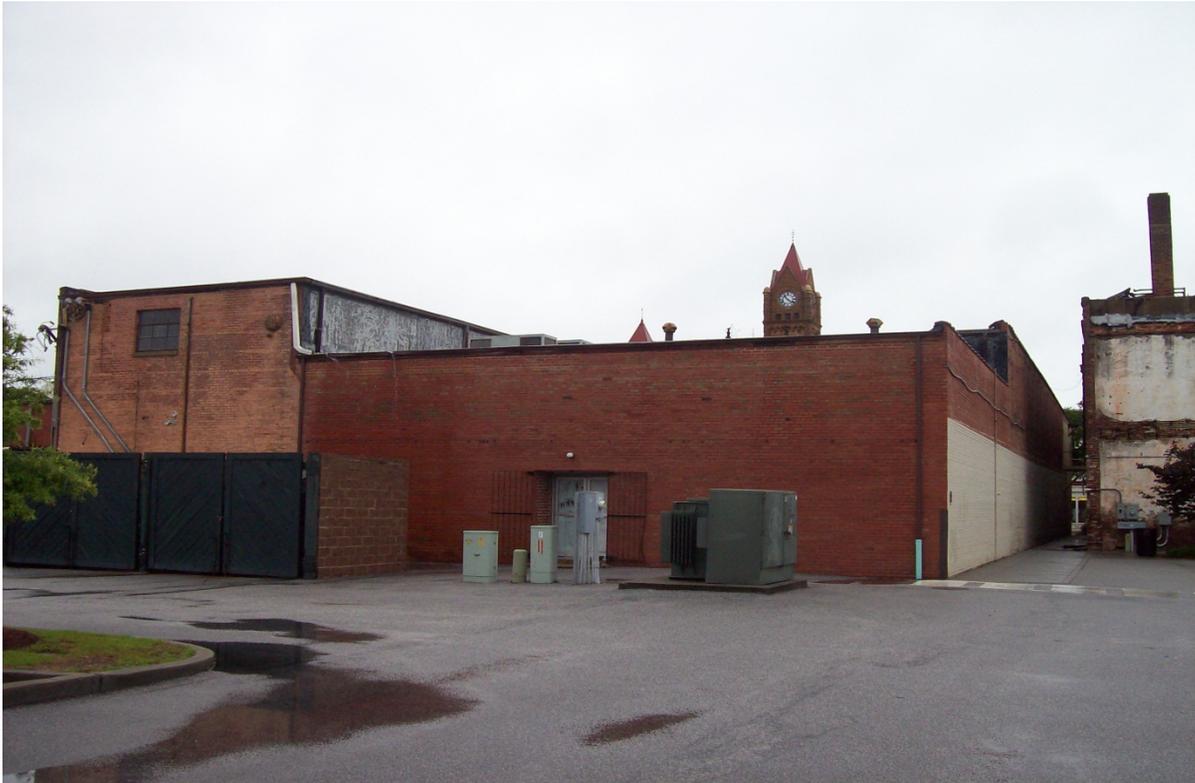
**Front & Rear of Maxway Building (2-story) measures: 75' x 195'**
