REQUEST FOR BIDS
ASBESTOS PROJECT DESIGN, AIR MONITORING & ABATEMENT
ITB #16-25/26
January 9, 2026

Emerald, Inc. was requested to conduct an Asbestos Survey of the vacant commercial structure located at 12 Kelly Ave. in Sumter, S.C., to identify the presence of any asbestos-containing materials (ACM), prior to demolition activities. The inspection was authorized by Mr. John Macloskie, Codes Director, with the City of Sumter. The inspection included identification and assessment of the condition of suspect asbestos-containing materials, either friable or non-friable, on the interior and exterior portions of the structure.

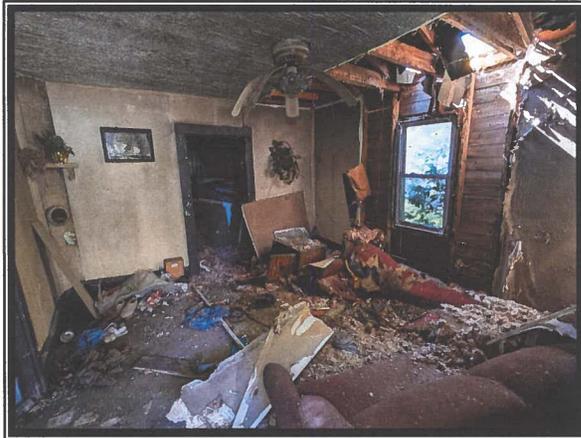
Photo #5
View Depicting the Significantly Damaged
Interior Area of Room B

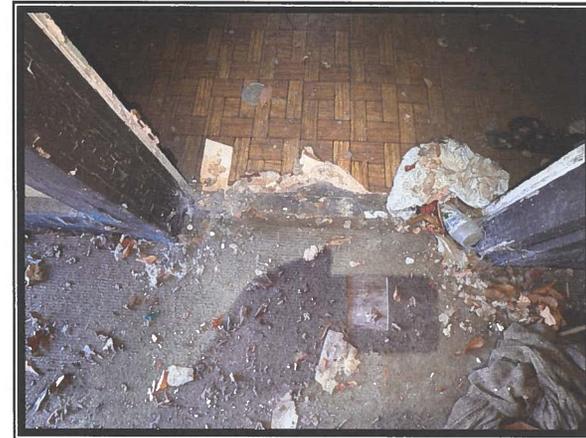
Photo #6
No Asbestos Detected in Any Sheet Flooring
Layers or Carpet Backing

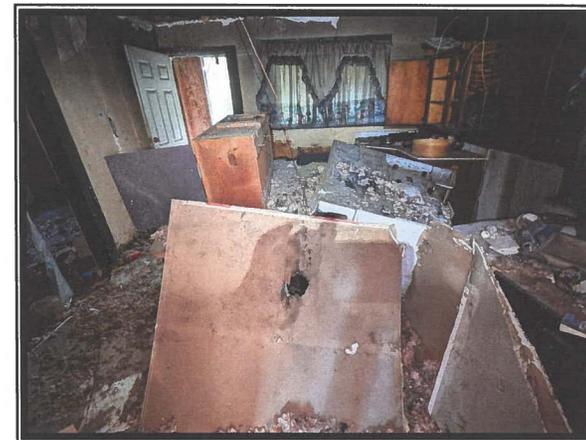
Photo #8
No Asbestos Detected in Sheetrock Systems
Associated with Ceilings or Walls

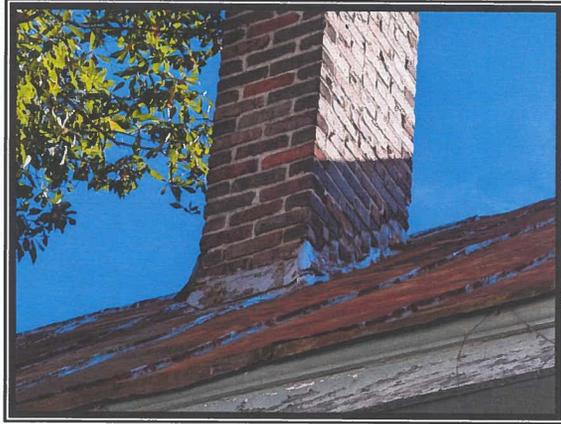
Photo #5
Chimney Flashing Material is Assumed to Contain Asbestos

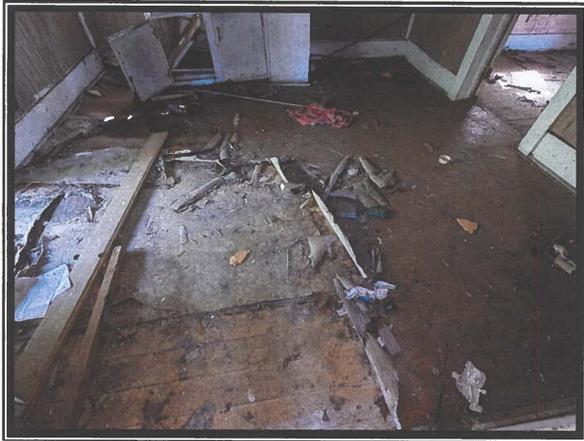
Photo #5
**Asbestos Detected at 15% in Tan-colored,
Bottom-layer Sheet Flooring in Room D**

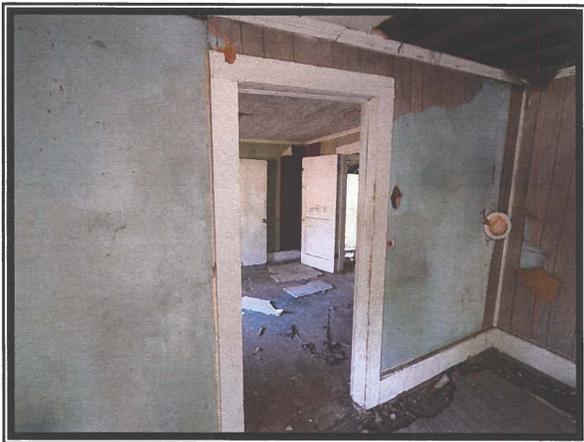
Photo #7
**Asbestos-containing Sheetrock Behind Wall
Paneling in Room A**

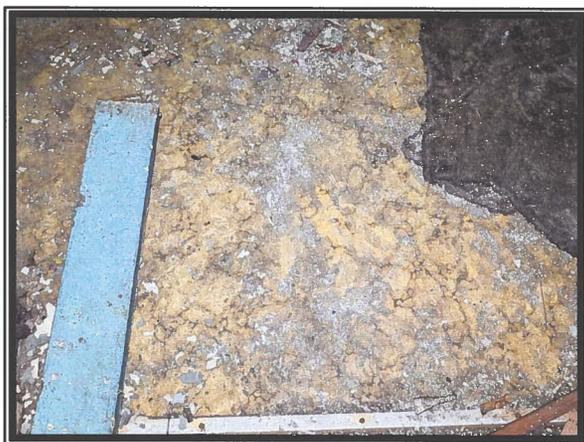
Photo #5
Asbestos Detected at 20% in Mottled Yellowish Tan Sheet Flooring in Room 1C

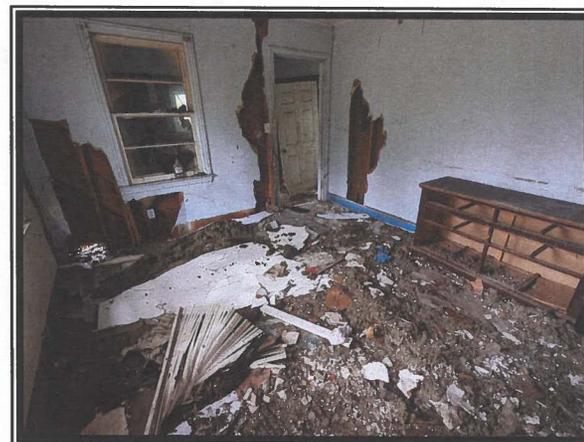
Photo #3
**Asbestos Detected at 4% in Sheetrock Wall
and Ceiling System**

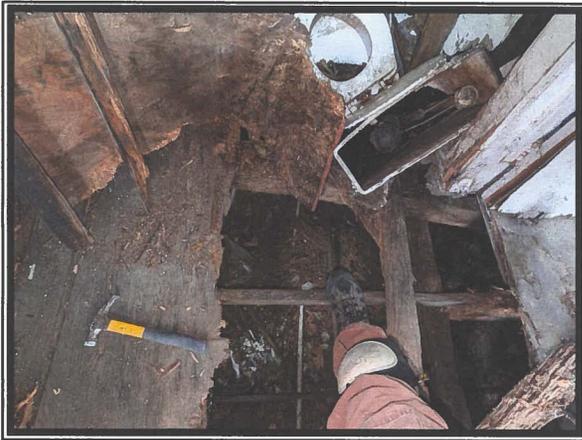
Photo #5
Asbestos-containing Sheet Flooring
Observed under Collapsed Floor Area

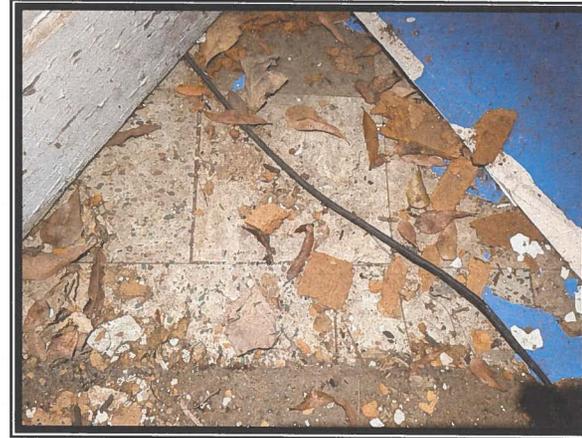
Photo #6
Asbestos Detected at 5% in Various 9x9
Floor Tile Types

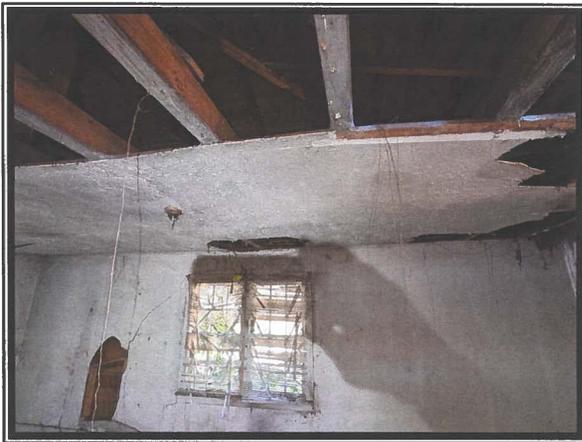
Photo #7
Asbestos-containing Stippled Ceiling
Texture on Remnant Ceiling Surface

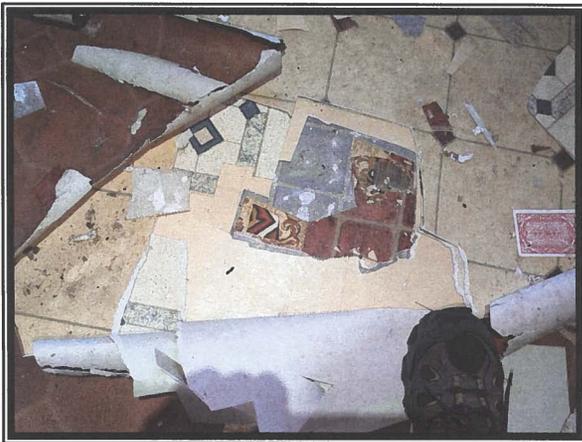
Photo #3
View Depicting Multi-layered Sheet Flooring with Asbestos-containing Layers in Room D

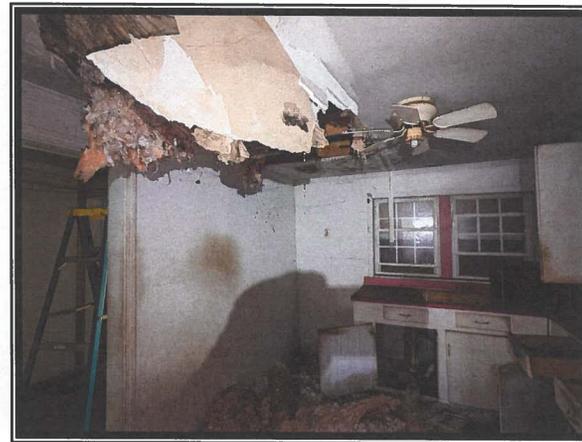
Photo #4
Asbestos-containing Sheetrock Ceiling System in Room G

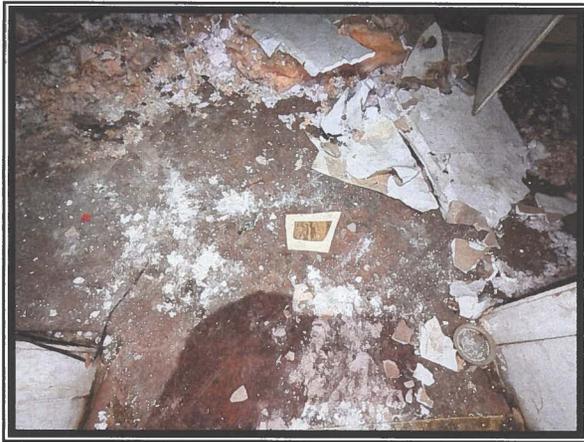
Photo #9
Asbestos-containing Sheetrock Materials
Scattered on Floor in Room G

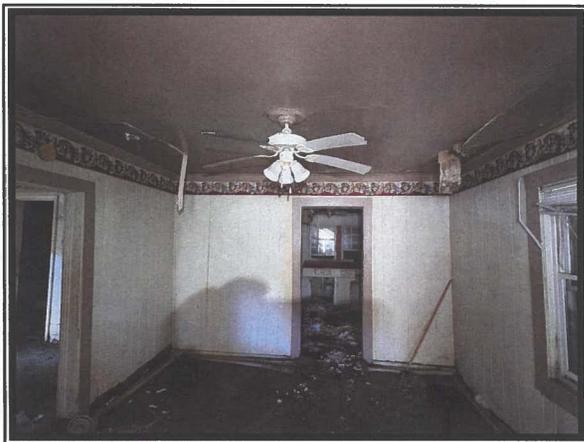
Photo #11
View Depicting Asbestos-containing
Sheetrock Ceiling System in Room D

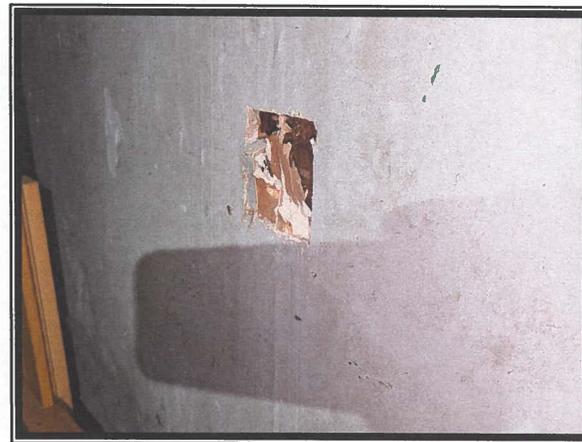
Photo #12
View Depicting Asbestos-containing
Sheetrock Wall System in Room H

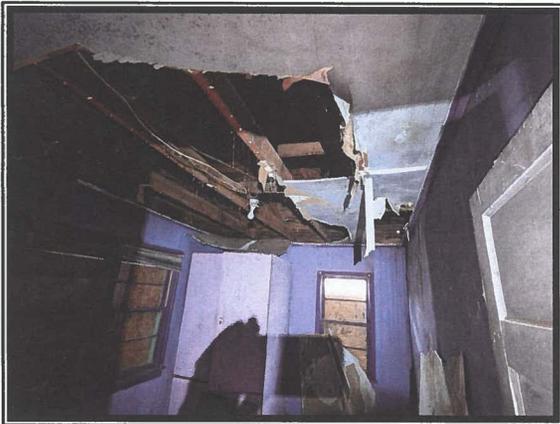
Photo #7
Significantly Damaged Sheetrock Ceiling in
Room C - No Asbestos Detected

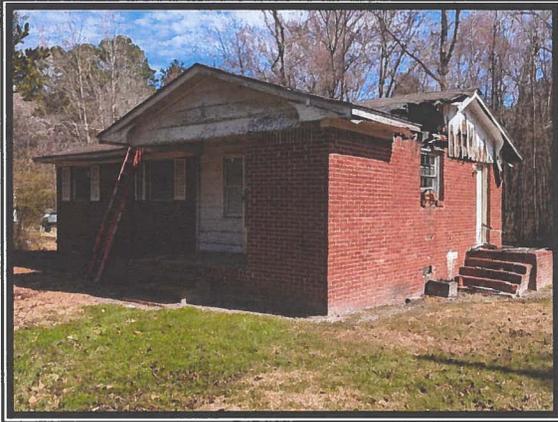
Photo #1
Northeast-facing View of the Residential
Building Depicting Damage at the South Roof

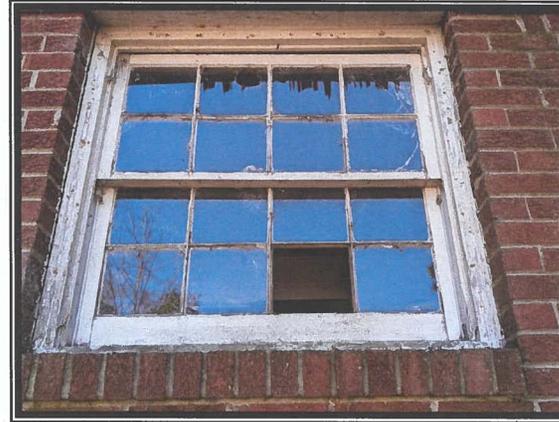
Photo #2
Asbestos Detected at 3% in Window Frame
Caulk (<0.11% Detected in Window Glaze)
