HISTORIC PRESERVATION DESIGN REVIEW

May 26, 2011

HP-11-15, 43 S. Main St. (City)

The applicant is requesting Historic Preservation Design Review approval for exterior renovations to the building on property located at 43 S. Main St. and represented by Tax Map # 228-13-07-054.

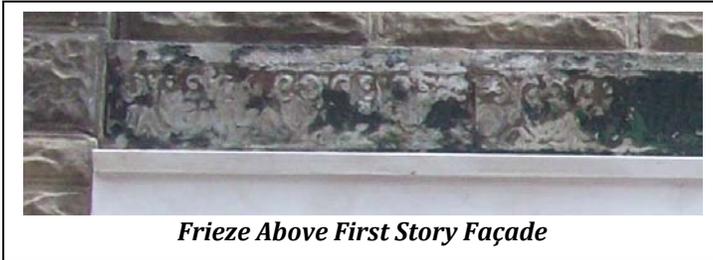
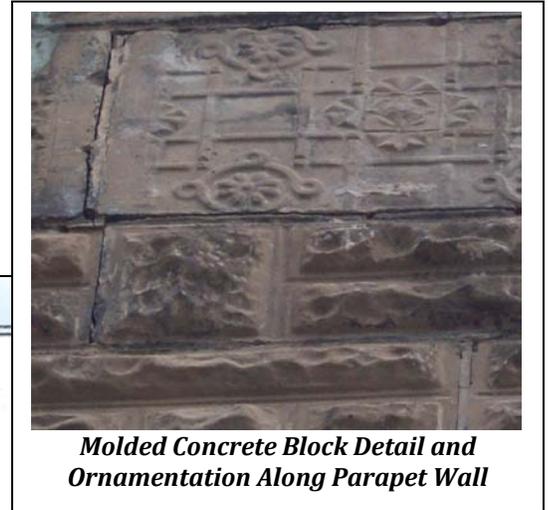
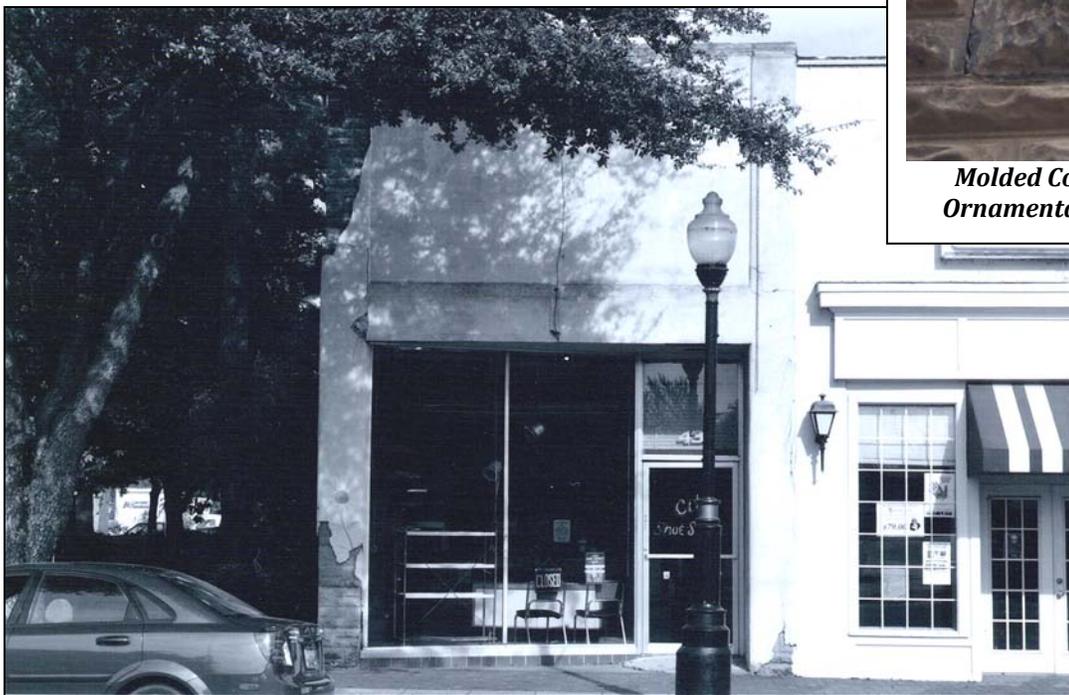
2010 HR Survey Record: Site # 1253 43 S. Main St., Sumter CBD

The recently completed Historic Resources Survey included the building as Site No. 1253, and describes the building as a “rectangular 1-part commercial block building with recessed entrance, display windows, originally had rusticated concrete block exterior.” The site record further notes that the façade “currently has a stucco exterior” and appeared to be c. 1940. The photograph above documents the exterior as it appeared at the time of the Survey, and shows the deterioration in the stucco at the street level.

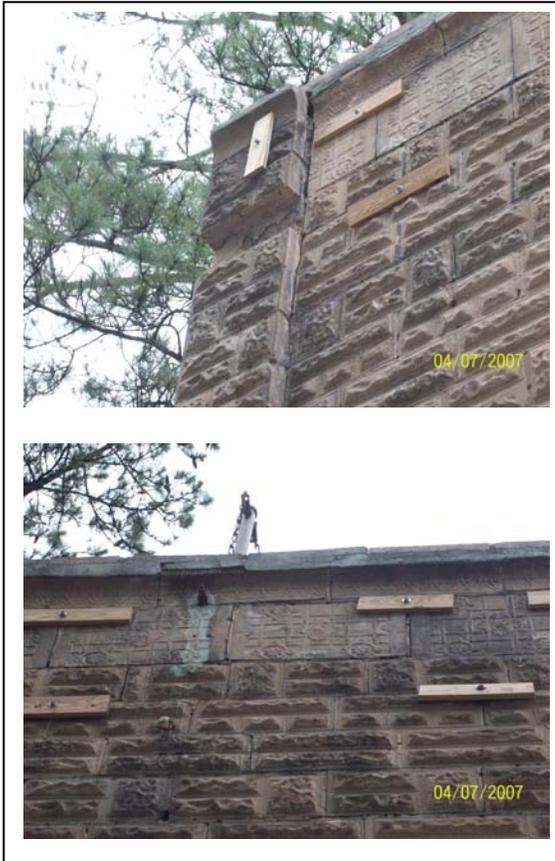
The Department issued a permit to remove the stucco from the façade in 2010 in order to discover the condition of the original masonry and any associated issues. There has been some deterioration in the mortar and cracking of a few of the concrete blocks and these had to be stabilized with bolts and blocks of wood (visible in the photos of the second story on the next page). These are proposed to be replaced with decorative metal stars and turnbuckles.

However the main issue is that underneath the stucco were wooden surrounds along the south wall and a constructed wood ceiling and molding along the top of the recessed entrance. When the stucco was removed this wood construction collapsed, leaving large open areas that had to be covered to protect the building from weather and other intrusions.

Staff visited the site on the day of the work and viewed the building, and after consulting with the Building Official a decision was made to allow covering the open areas to protect the building. The applicant did this with simple beaded board ceiling, wooden wall wainscot paneling and architectural molding, primed in white.

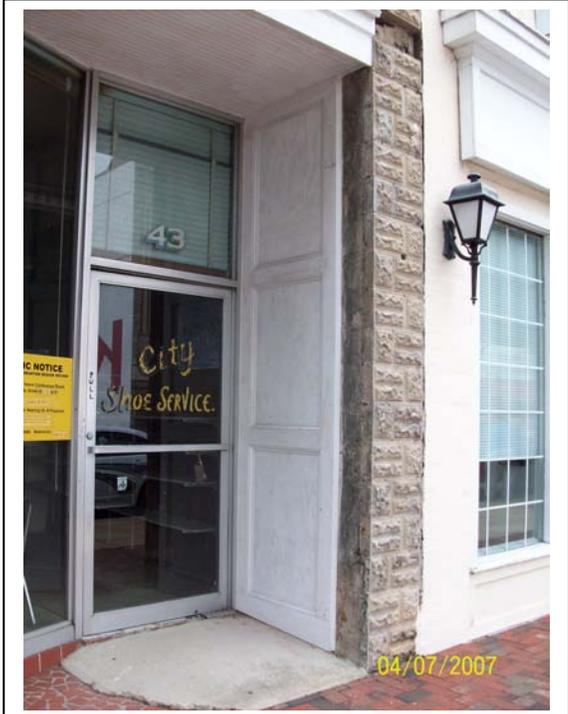
The wooden areas of the façade were not original to the building but were placed to support and frame the recessed entrance. When the aluminum storefront was installed the wooden support areas were made of plain finished plywood and were not sympathetic to a historic downtown. The design elements of the emergency replacement woodwork were taken from other buildings in the downtown in order to be more in keeping with the original period of construction.

The intent is to restore the altered street front façade to an aesthetically pleasing historic appearance and to stabilize the masonry, especially along the upper story façade. The lower façade woodwork including the ceiling, molding, and south wall with wainscoting is proposed to be painted white.
