City of Sumter Historic Preservation Design Review

May 26, 2022

HP-22-06, 6 Church St.

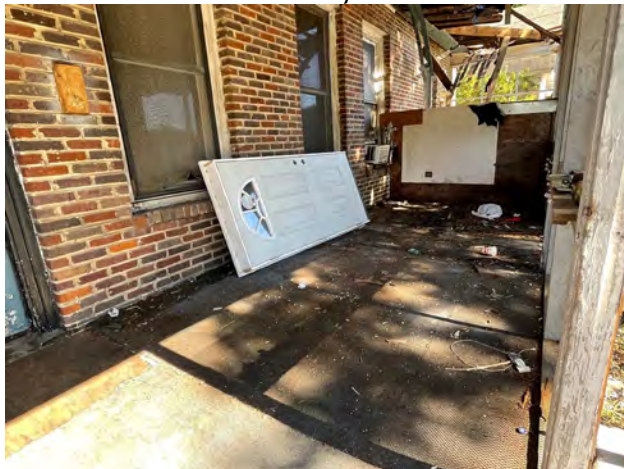
Porch Decking

1. Install new screen sections where original screens and doors are missing
2. Replace deteriorated porch flooring
3. Repair roof covering porch
4. Repair Brick Porch closed-riser stairs
5. Replace Skirt Boards
6. Column Shaft, Capital, and Base replacement

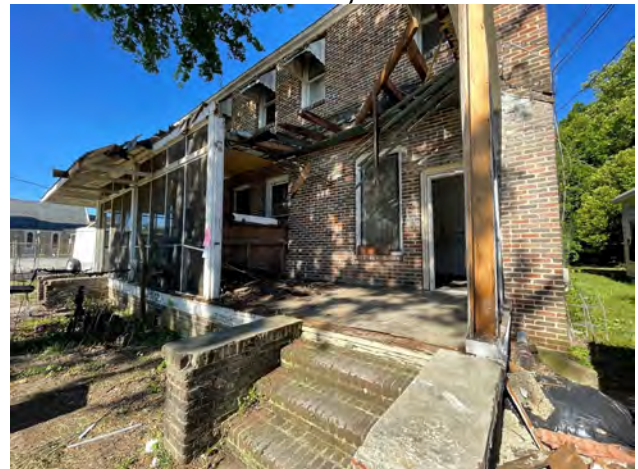
Porch Decking and front steps

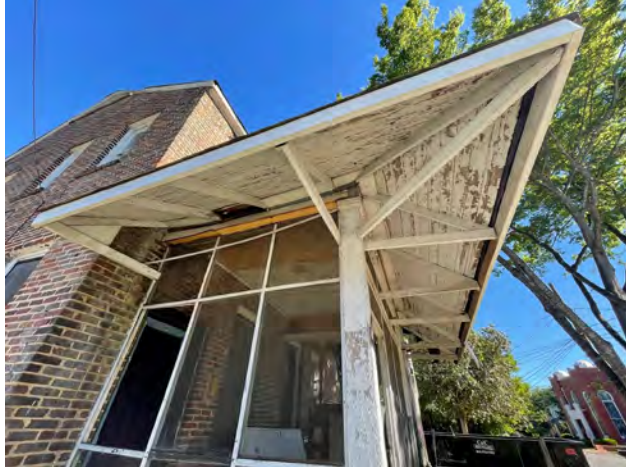
Porch Ceiling

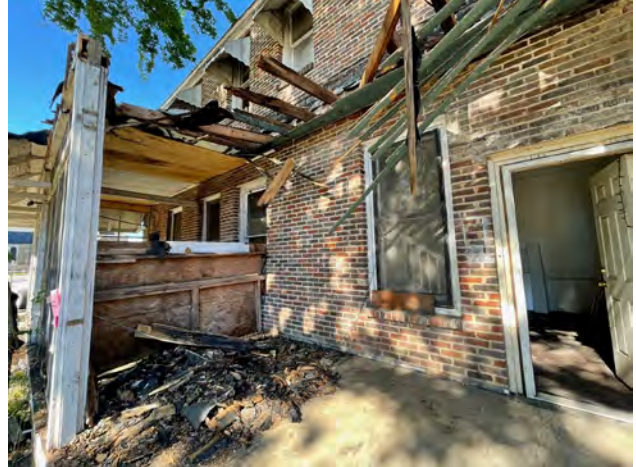
The house is currently configured as a duplex. A stop work order was issued on April 21st, 2022, by both the Planning and Building Departments terminating current demolition of the front porch on the property, as the property owner had not obtained proper Historic Design Review approvals and permits to conduct

Partial Demolition prior to Stop Work Order

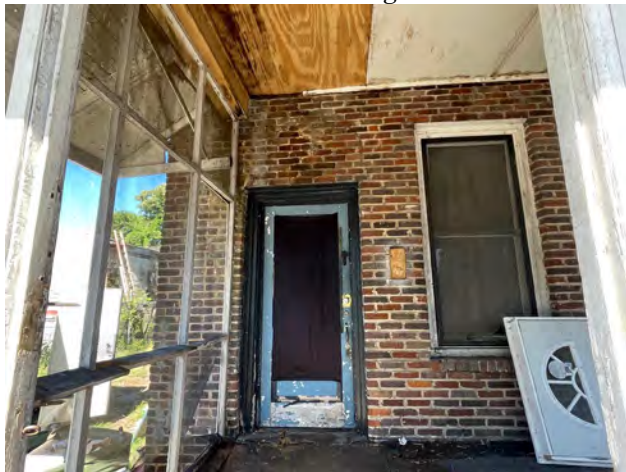
Ceiling Deterioration

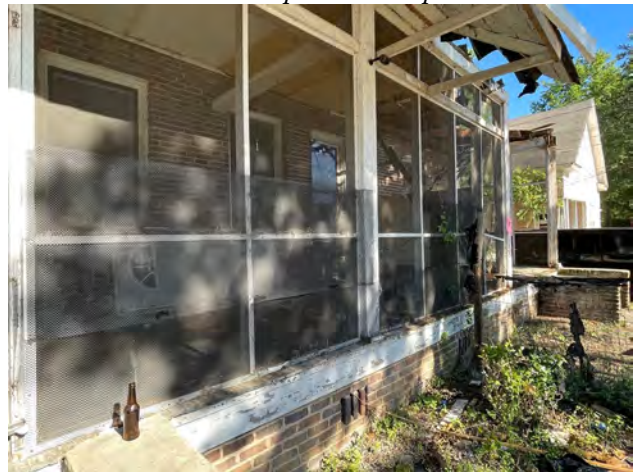
Screen Deterioration

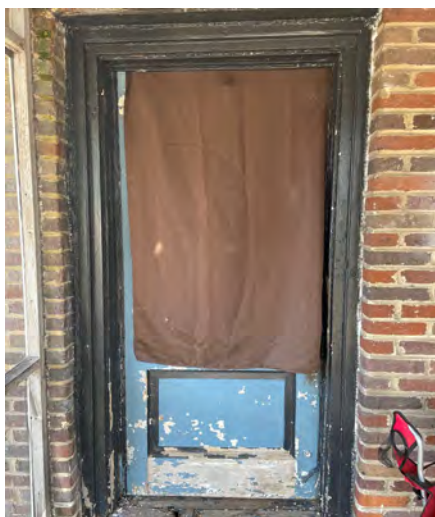
Half Light Existing Door

The applicant is proposing to replace the two (2) existing exterior doors located on the front porch with white craftsman sunburst steel doors. The Design Review Guidelines state that original doors that are beyond repair can be replaced with a door resembling the existing or one that reflects the buildings architectural style. While the replacement doors do not resemble the original half-light style, the proposed Sunburst design meets the general intent of the district.

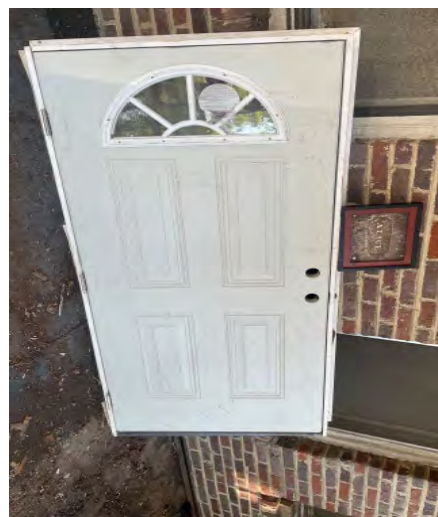
Proposed New White Sunburst
