# Historic Preservation Design Review

March 27, 2014

## HP-14-03, 41 W. Liberty St. (City)

**Request:** Design review approval for proposed façade restoration/renovations to include: new windows, doors; and repainting to match prior and return to original design.

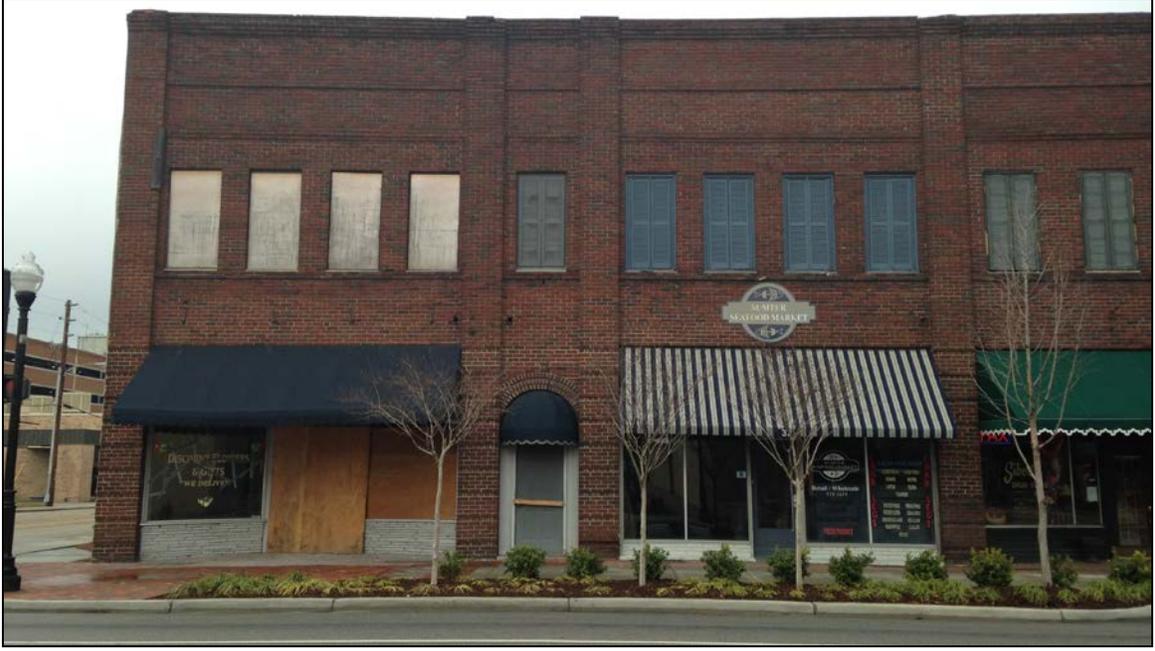
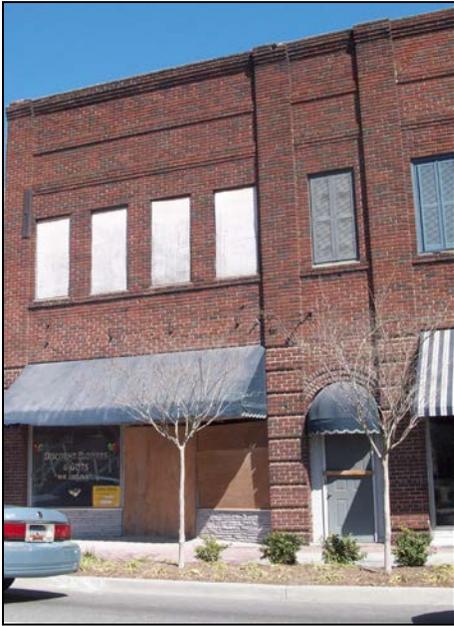
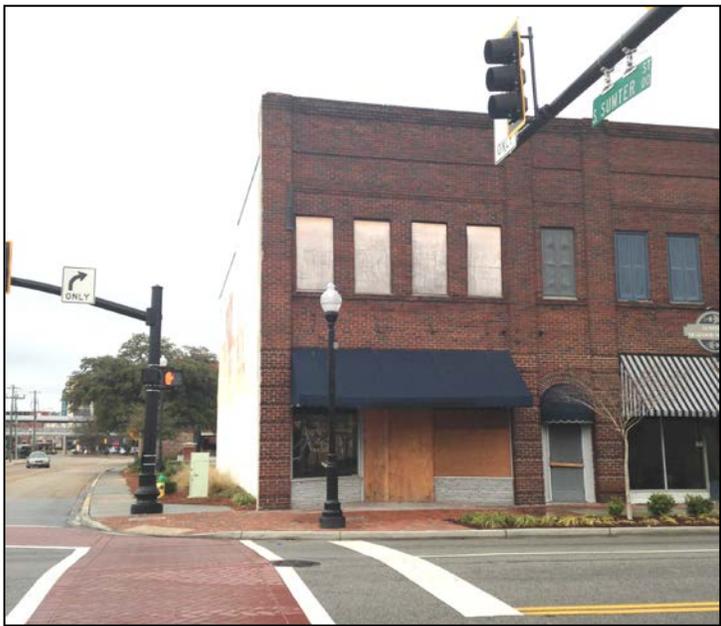
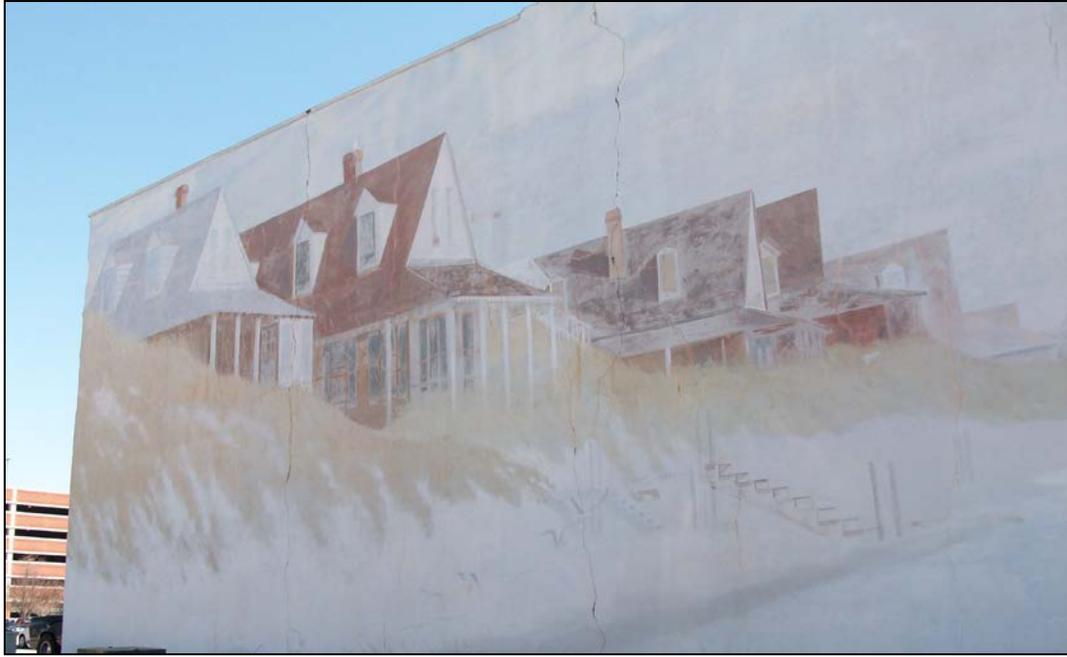
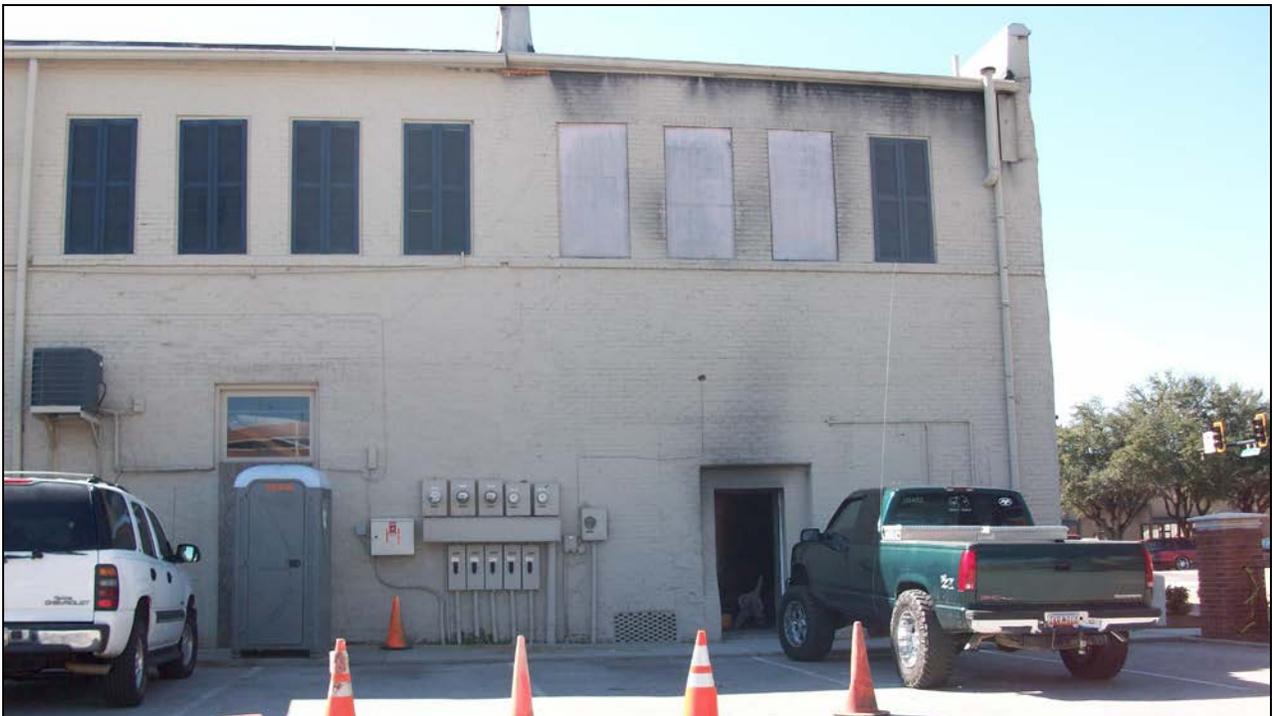
The building is located on the north side of Liberty St. between Sumter St. and the seafood market. A fire in 2013 destroyed the interior of this building. The photographs below show the existing façade.

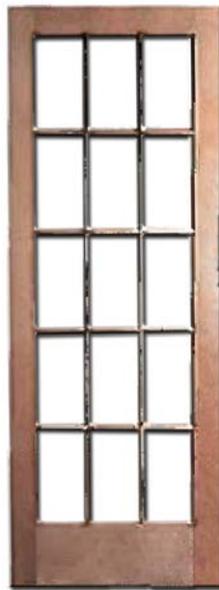
**6627 PINE IG**

1. Replace the front door with #6627 Pine IG from Dealers Supply and Lumber Co. to be installed as double doors:

(Note: the applicant has requested approval to use snap-in plastic sashes in the transoms and doors, but did not include a photo of the product. The photos included in this report are what the applicant initially proposed for use, and staff recommends the use of the higher quality wooden sash doors and transom.)

1. Replace the front door with #6627 Pine IG from Dealers Supply and Lumber Co. to be installed as double doors with snap-in wooden mullions on inside of doors;
2. Install a transom above the double doors (#6705 Transom) from Dealers Supply and Lumber Co.;
3. Repaint the doors 'Golden Oak' stain;
4. Replace windows with new plate glass, wooden trim around windows to be painted 'Coventry Gray' HC169 ;
5. Repaint the rear of the building to match existing color – Benjamin Moore 'Baby Turtle' 2B 515;
6. Same wooden door to be placed in rear, and stained same as front;
7. Shutters replaced and painted to match existing;
8. Blue fabric awning placed on rear of building to match awning in front.
9. Lighting to be added underneath awning, will not be visible.

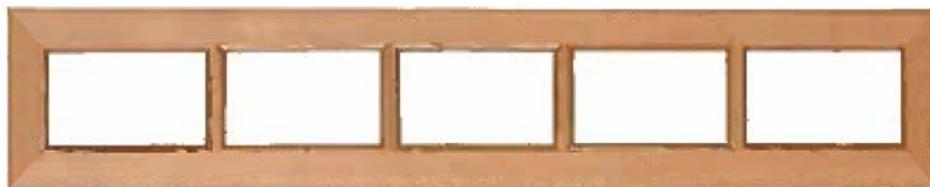
**6705 Transom**

2. Add a transom above the double doors (#6705 Transom) from Dealers Supply and Lumber Co.:

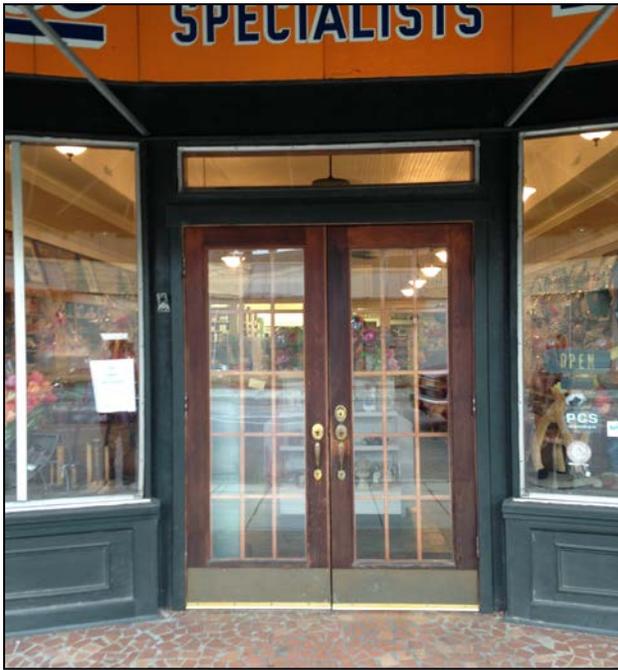
3. Stain doors to match Sibert's Drugstore: (note: trim around windows will match existing, closest color match is Benjamin Moore's 'Coventry Gray' HC169 )

4. Repaint the door to match the wood color of Sibert's Drugstore 'Golden Oak' stain color. (See above)
5. Replace windows with new plate glass, wooden trim around windows will also be 'Coventry Gray'.
6. Repaint the rear of the building to match existing color. Closest color chip is Benjamin Moore 'Baby Turtle' 2B 515. (Note: Air conditioning unit is to be mounted on rear wall of building, typical with adjacent businesses.)
