HISTORIC PRESERVATION DESIGN REVIEW

HP-11-16, 49 S. Main St. (City)

The applicant is requesting Historic Preservation Design Review approval for exterior renovations to the building on property located at 49 S. Main St. and represented by Tax Map # 228-13-07-057.

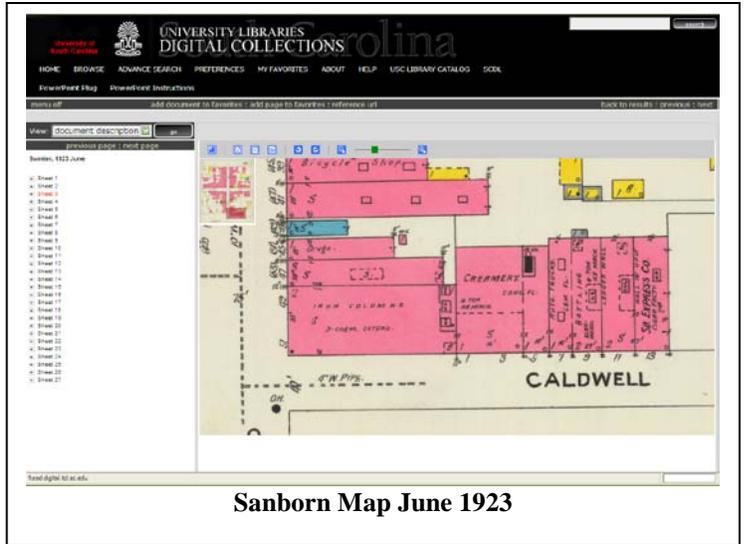
Sanborn Map June 1923

building. It is described on the recent Historic Resources survey card as Site #1256, which states the building is of masonry construction, with “recessed entrances, first story tile exterior, second story aluminum façade; paired 6/1 dhs windows on north elevation.” The building appears on the Sanborn Insurance Maps in June 1923 where it states that the building has “Iron Columns,” and notes that there are 3 water closets and an electrical connection at the rear of the building and “3 Chem[ical] Ext[in]g[uishe]rs.” There is no information about its actual use prior to the era of the vintage photograph provided by Mr. Sammy Way at The Item, showing the original façade with a marquee-style awning and signage as the “S. H. Kress 5-10-25-cent Store.” A copy of this image is

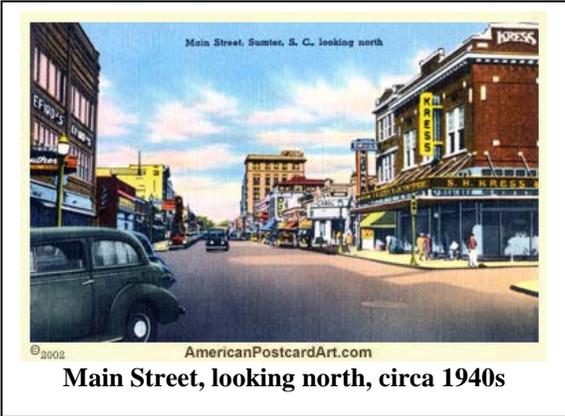
Main Street, looking north, circa 1940s

provided in the packet. The old postcard image to the left prominently features the building and shows ornate pediments at the top of the building at the front and on the Caldwell St. side, as well as clearstory glass storefronts and suspended wrap-around awnings.

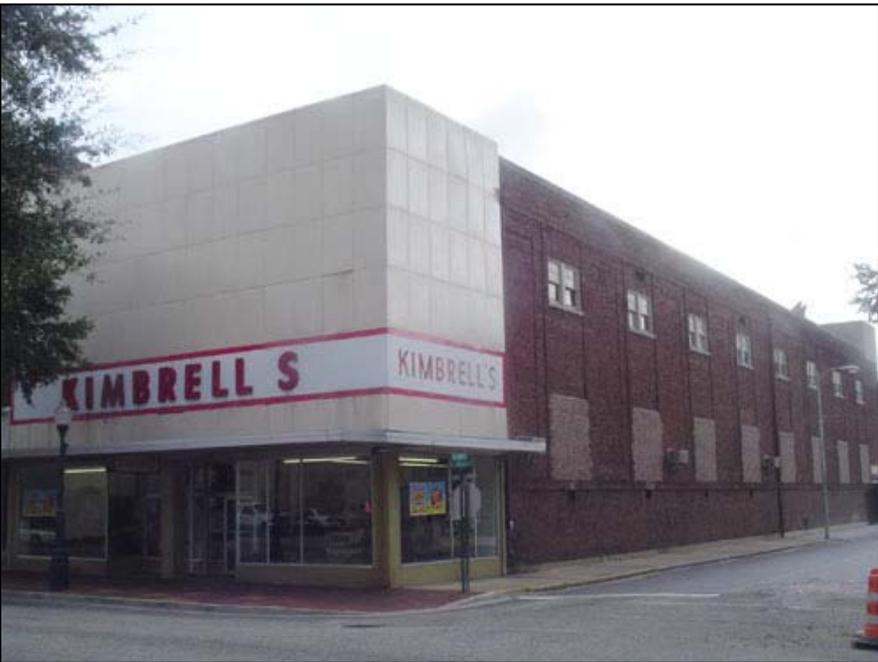
2010 HR Survey Record: Site # 1256, 49 S. Main St., Sumter CBD

The three-story building is rectangular in shape with a flat roof surrounded in the front by a parapet wall. The façade was altered in the mid-20th century with an applied aluminum and glass storefront. The upper-level façade was damaged and fell during a recent windstorm, and has resulted in the application for this renovation.

The photograph below documents the exterior as it appeared prior to the removal of the 20th-century aluminum façade.

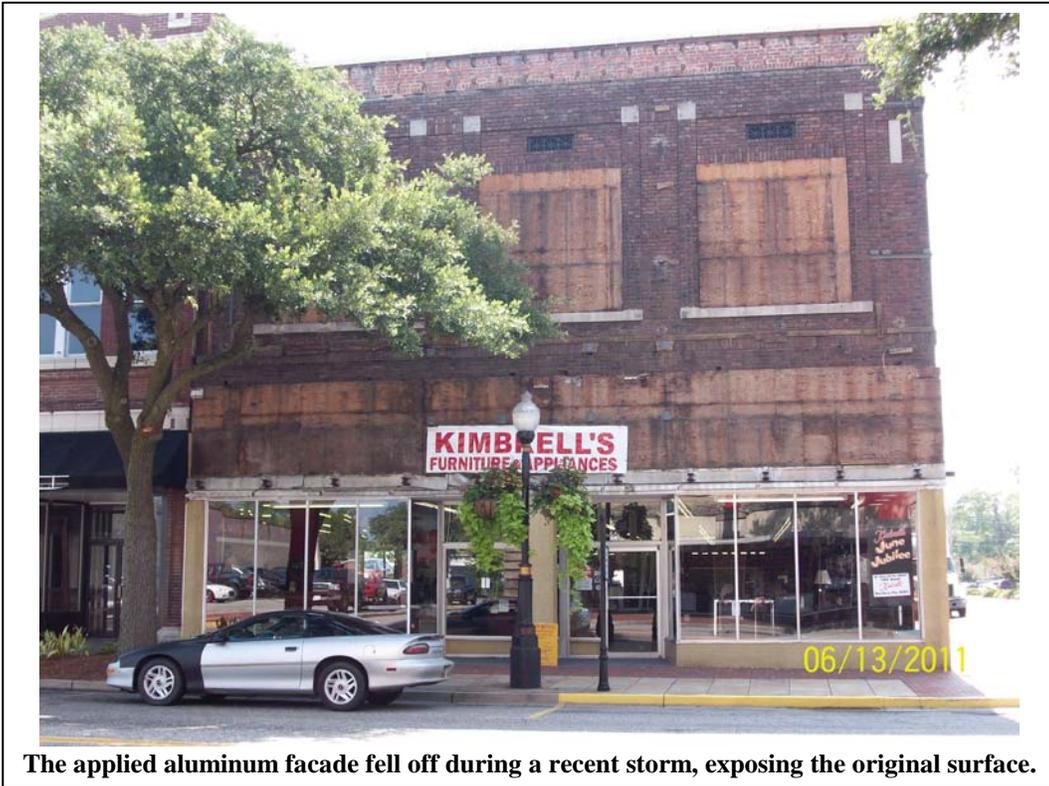
The applied aluminum facade fell off during a recent storm, exposing the original surface.

The applied façade was on the Main Street section and wrapped around the side of the building on Caldwell Street, and the proposed renovations will cover the same area. There is a large area of brickwork and bulls-eye detailing on the side that will be exposed and renovated as well as the upper-story windows, friezework, cast concrete and stone details, decorative metal vents, and applied cornice and mouldings across the parapet. All new architectural details and replacement materials will match what can be gleaned

The work will begin with the removal of all bracketry and support systems that supported the applied aluminum façade and subsequent repair of the mortar and masonry, as well as cleaning, repairing, and painting of the original decorative metal vents and concrete details above and below each window system. The removal of plywood sheathing from the transom areas over the storefront, and repairs and stabilization of this area will be undertaken in order to assure support for new metal sheathing and brackets for the new awnings. This area will not be visible when the work is complete and the new signage and awnings are installed.

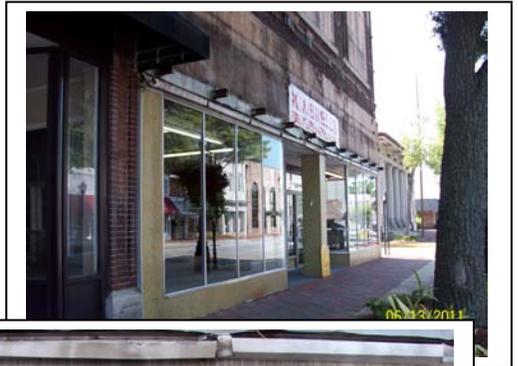
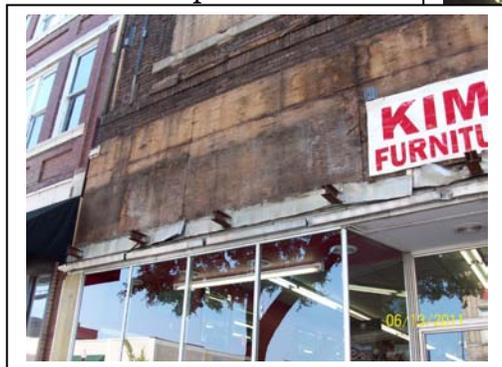
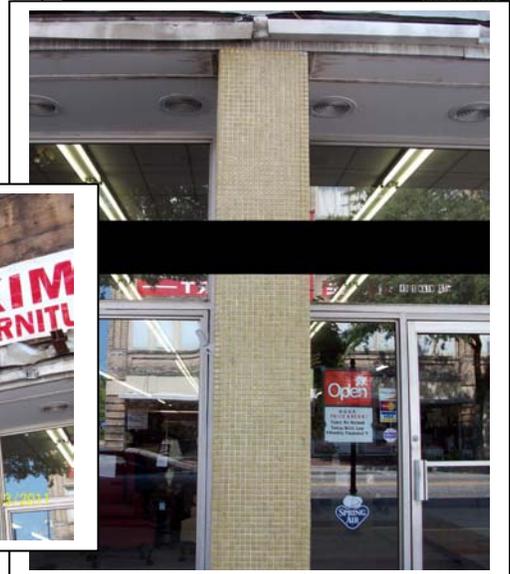
The upper level façade is to be restored by cleaning and repairing the original brickwork, the installation of replacement mouldings and frieze, the application of a new cornice to cover “common red” brick that does not match that of the rest of the building, and repair or replacement of the original twelve-over-one windows that may be seen in earlier depictions of the building. It is assumed that the original windows are intact and are merely covered with plywood. Paint colors selected from the Sherwin-Williams Arts & Crafts Palette will be applied to the mouldings, trim, and

signage as detailed at the top of the next page.

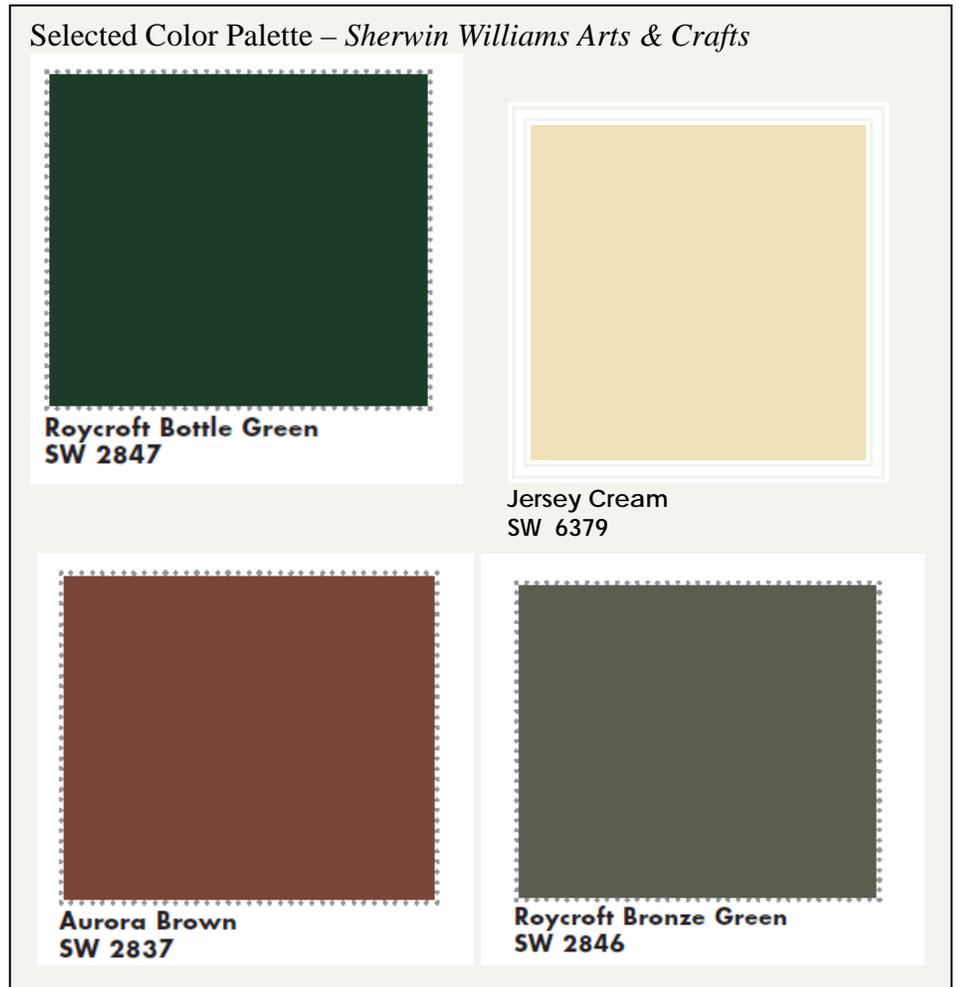
The intent is to restore the altered street front façade to an aesthetically pleasing historic appearance without removing the existing storefront or the mid-20th century yellow tile due to extensive cost and possible damage to the building. The tile is proposed to be painted Aurora Brown (SW 2837) which closely matches the existing brick, with an applied wainscoting in Roycroft Bronze Green (SW 2846). The aluminum storefront windows and entrance door will be cleaned but will remain unaltered.

A shed-style awning of Sunbrella canvas in the color _____ is to be placed over the display windows and entrance, completing the restoration work.

The proposed renovations to the storefront area including painting and applied wainscoting are simple, appropriate, and in keeping with the original character and early twentieth century architecture of this building. The new elements replace or transform deteriorated areas that were not original to the building and were out of character with its original architecture. The tiled column will remain and will have the same applied color treatment as the tiled areas surrounding the storefront.

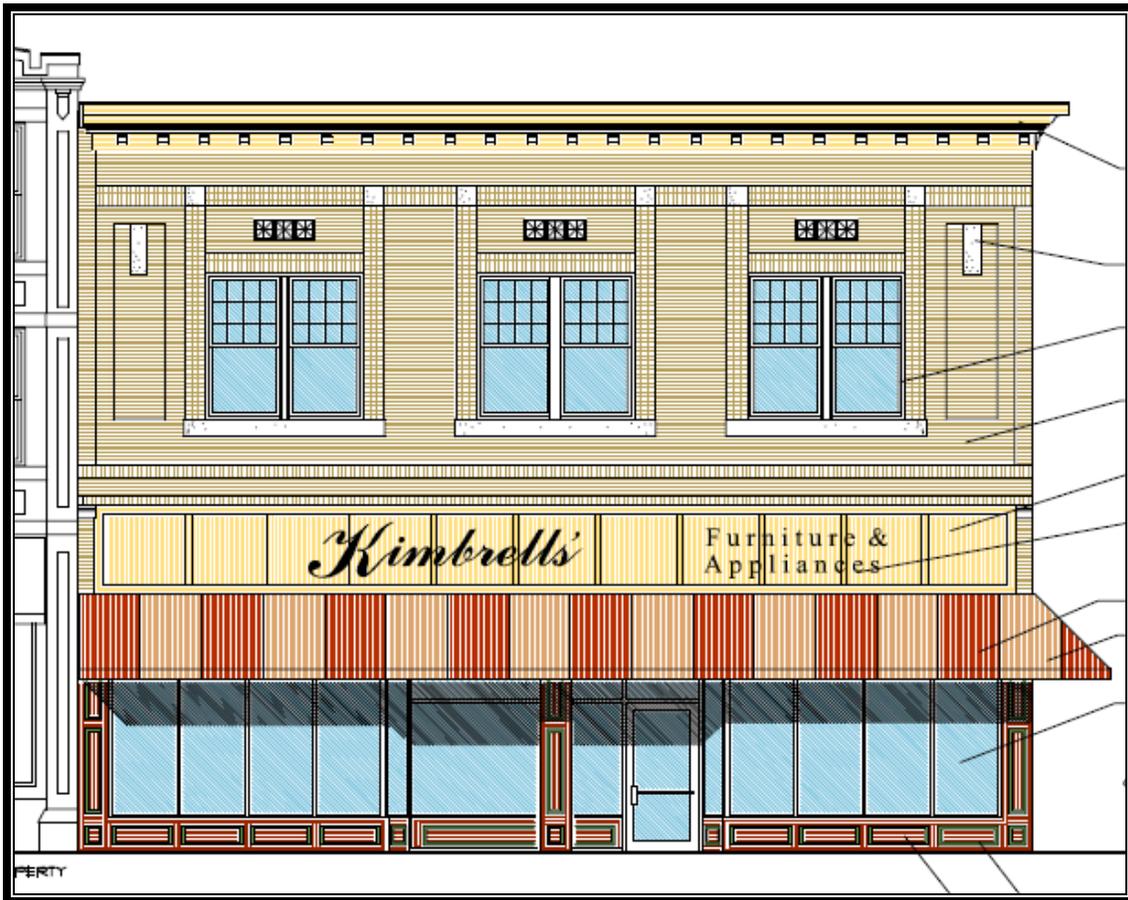
Proposed renovations to Kimbrell's Furniture Building
