# City of Sumter Design Review Board

## HP-22-13, 210 Church St.

<b>Applicant:</b>	Robert Burleson
<b>Status of the Applicant:</b>	Authorized Agent for Property Owner
<b>Request:</b>	Request for Design Review approval for construction of a new second floor access stair at the rear of the residence.
<b>District</b>	Hampton Park Historic District
<b>Location:</b>	210 Church St.
<b>Present Use/Zoning:</b>	Residential / R-6
<b>Tax Map Reference:</b>	228-05-05-023
<b>Adjacent Property Land Use and Zoning:</b>	North – Single-Family Residential / R-9 South – Single-Family Residential / R-6 East – Vacant / R-6 West – Single-Family Residence / R-6

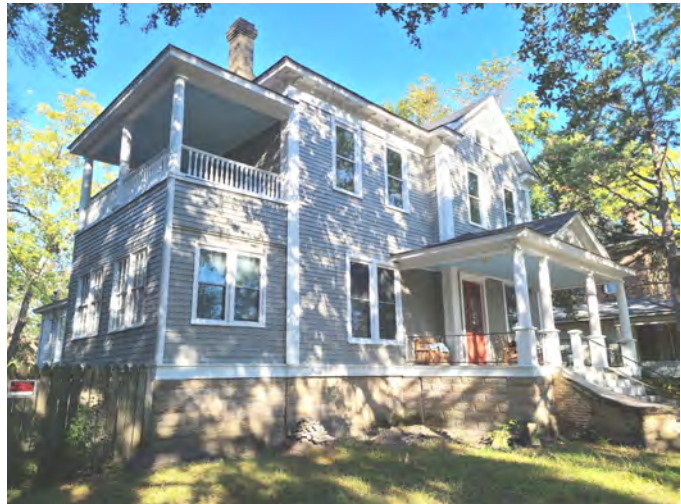
210 Church St., shown in the photograph to the right, is a two-story frame house. The home is located on Church St. between W. Calhoun St. and Haynsworth St.

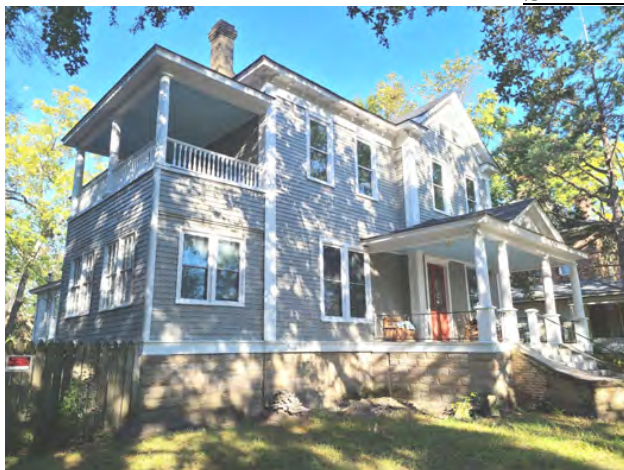
*Front Façade*

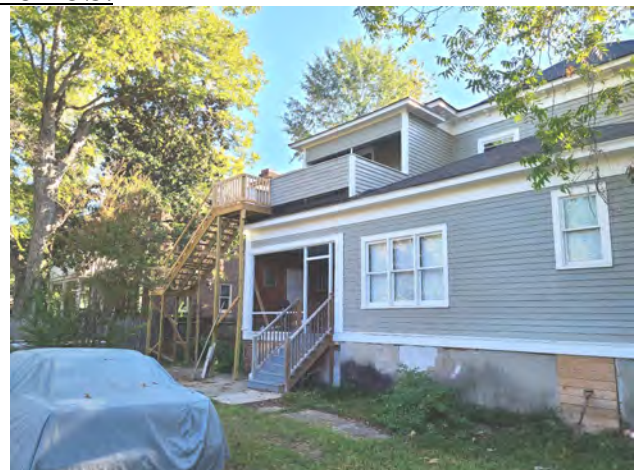
*Rear Façade, as viewed from southwest corner of lot, showing area of proposed alteration.*

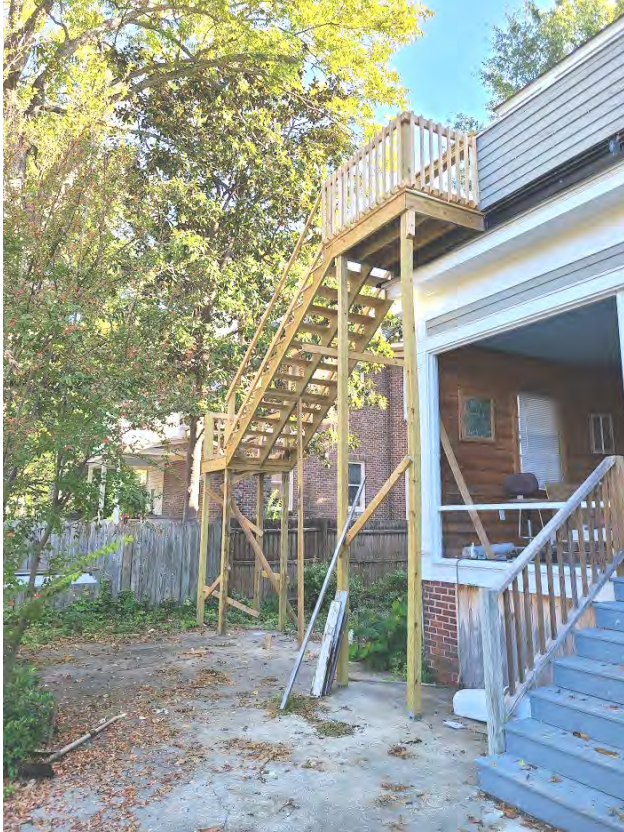
The current configuration of the staircase constructed prior to the stop-work order appears to conflict with required building setback requirements. As a result, the applicant has submitted a proposed configuration that would preserve the already-constructed second story landing but reconfigure the staircase to exit directly to the rear of the residence and turn at a lower landing 90 degrees before meeting the ground level in the center of the property's rear yard.

*Above: Partially constructed staircase (built without permits), proposed to be removed to the upper landing and reconstructed in configuration as proposed by this application*

Though construction of the 2<sup>nd</sup> floor access stair is warranted, the proposed materials do not match the existing structure, and no attempt has been made via the proposed designs and course of action submitted to integrate the exterior access stair into the residence as a whole. As a result, the proposed design is generally inconsistent with the Design Guidelines.

Staff recommends **denial** of this request.

While construction of a 2<sup>nd</sup> floor access stair is a valid improvement for the residence, the proposed changes are inconsistent with the City of Sumter Historic Preservation Design Guidelines and are incompatible with the existing building design. An alternative design that is integrated with the building would be more consistent with the intent of the Design Guidelines.

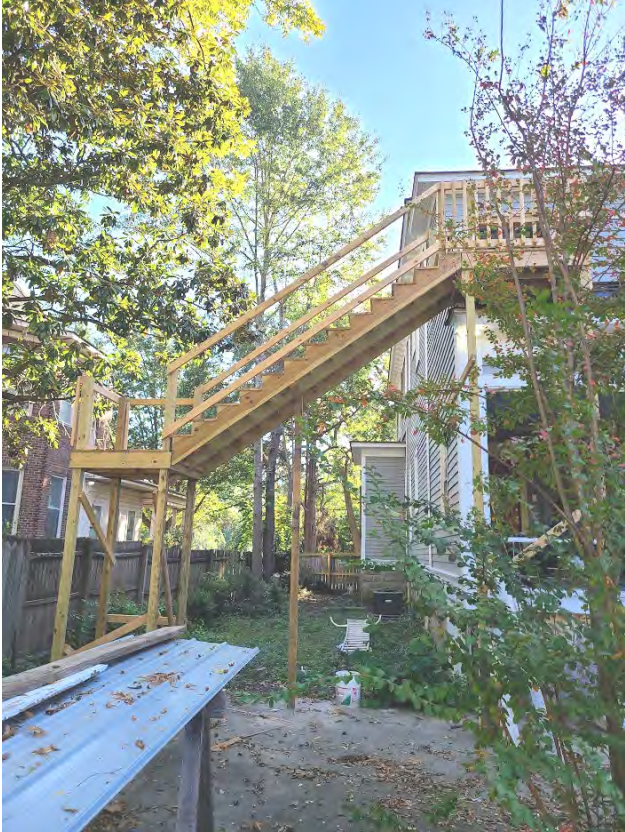
*Above: Partially constructed staircase as viewed from rear.*

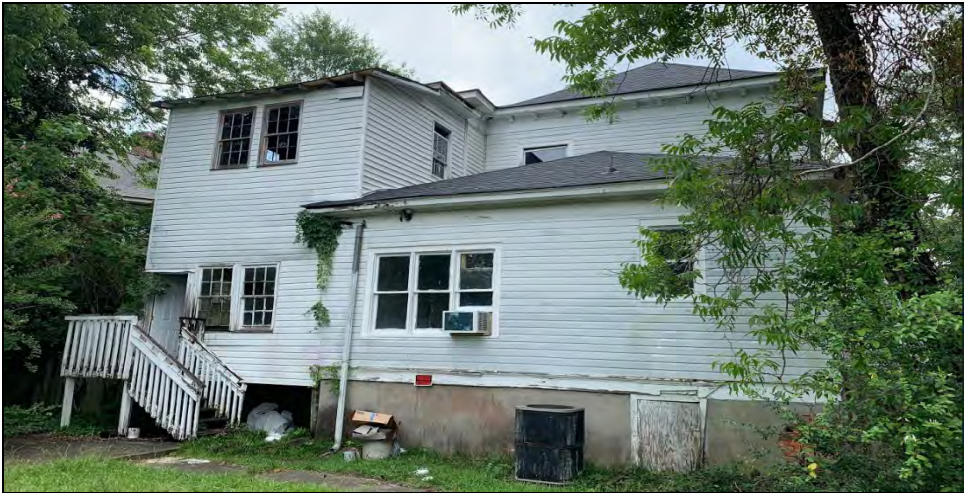
**Above:** rear view of residence prior to alterations approved via *HP-19-13* showing previous 1<sup>st</sup> floor rear access stair configuration and covered 2<sup>nd</sup> floor addition that has been modified.

The location of the proposed 2<sup>nd</sup> floor exterior staircase was previously occupied by a 1<sup>st</sup> floor exterior staircase and landing. In addition, prior to renovations completed under *HP-19-13*, an internal 2<sup>nd</sup> floor access stair was located inside the 2-story addition. Due to structural deficiencies identified in the addition, the renovations under *HP-19-13* included removal of that access staircase and conversion of the addition to open porch space. While the residence contains at least 1 internal access staircase to the 2<sup>nd</sup> floor, the floor plan of the residence and need for emergency egress does warrant construction of a 2<sup>nd</sup> floor access stair.
