City of Sumter Historic Preservation Design Review

September 26, 2024

HP-24-09, 219 W. Calhoun St. (City)

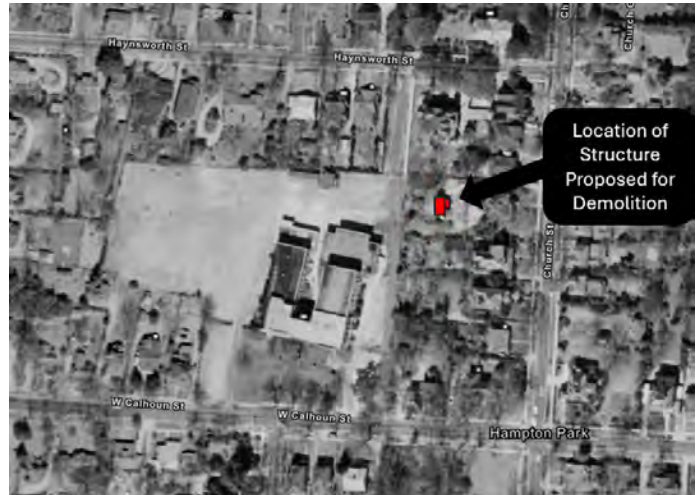
Figure 1 – 1957 Aerial Imagery of Site while used as McLaurin Jr. High School. (Location of subject structure marked in red.)

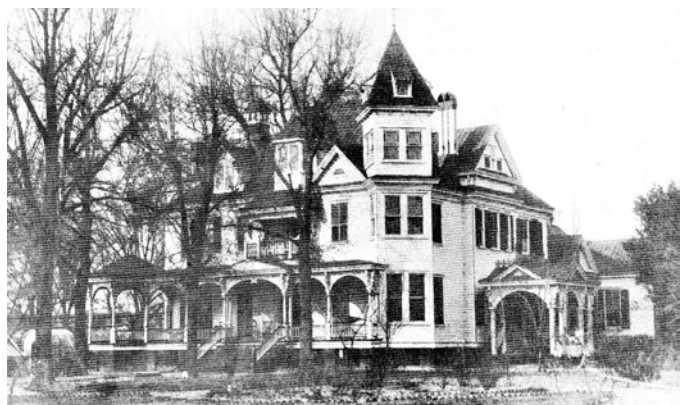
Figure 2 - Former Residence at Corner of Church and Haynsworth Streets

The building was originally an accessory residential structure for household staff for the since-demolished "Harby House", which was located at the corner of Haynsworth St. and Church St. After 1912 and before 1915, construction of the home now located at 218 Church St. resulted in the subject structure becoming part of that lot, where it appears to have

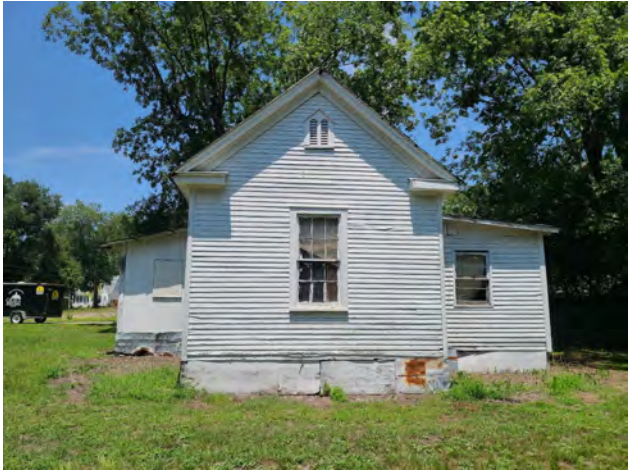
Above: South-facing Building Elevation

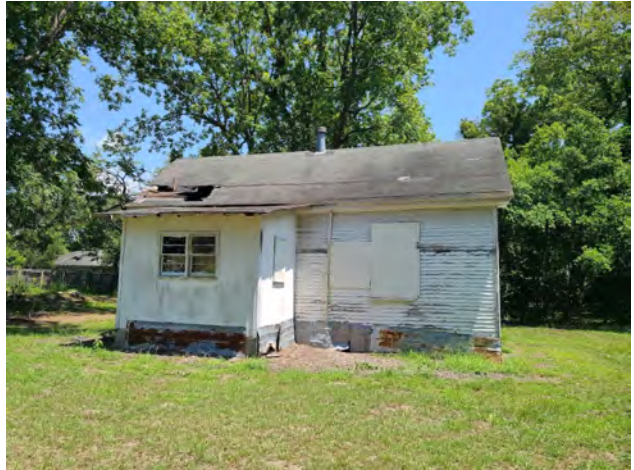
Above: West-facing Building Elevation

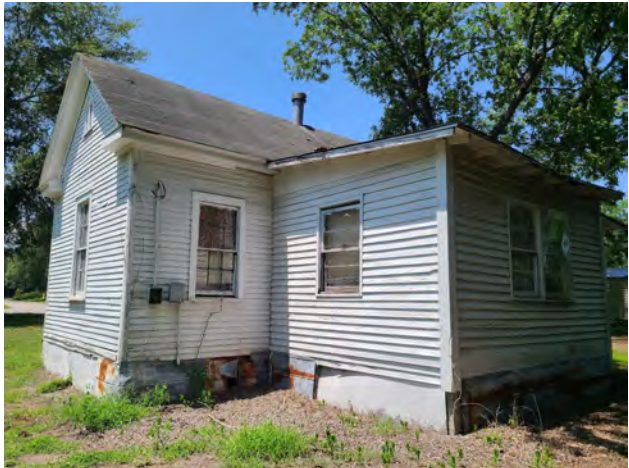
Above: East-facing Building Elevation

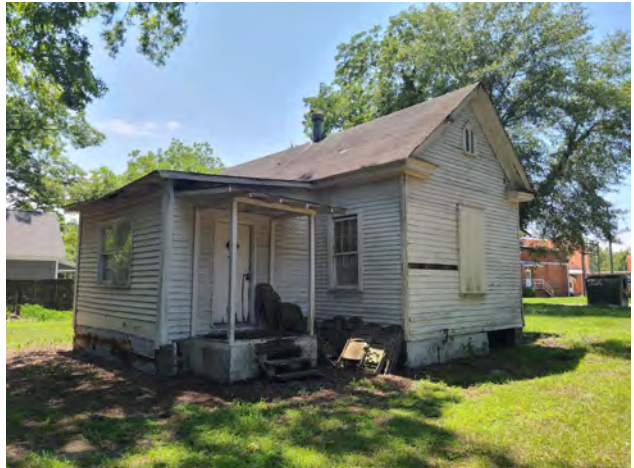
Above: North-facing Building Elevation

- 3) **Loss of Structural Integrity:** While the building is in a clear state of decay and disrepair, particularly as evidenced by the large hole in the roof on the northwestern corner, the specific details concerning structural integrity have not been established by a licensed architect or structural engineer that fully documents the building's physical condition, provides a reasonable cost estimate for the necessary repairs, and justifies why such repairs are not feasible.
