# Historic Preservation Design Review

February 24, 2011

## HP-11-04, 106 Church St. (City)

<b>Applicant:</b>	John Macloskie for the City of Sumter
<b>Status of the Applicant:</b>	Agent for City Code Enforcement
<b>Request:</b>	Demolition of House in the Hampton Park Historic District
<b>Location:</b>	106 Church St.
<b>Present Use/Zoning:</b>	Vacant Residential/R-6 (Single Family Residential)
<b>Tax Map Reference:</b>	228-12-01-027
<b>Adjacent Property Land Use and Zoning:</b>	North – Residential/R-6/Hampton Park Historic District South – Residential/R-6/Hampton Park Historic District East – Residential/R-6/Hampton Park Historic District West – Residential/R-6/Hampton Park Historic District

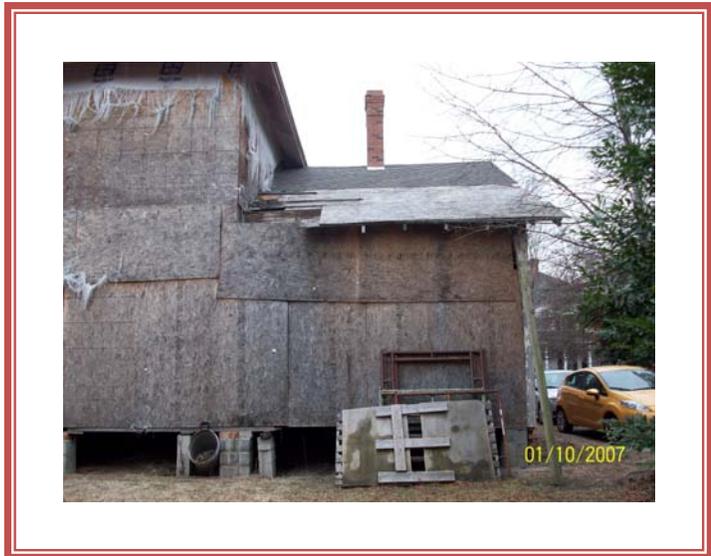
- Shifting of blocks placed to attempt to support the structure in the rear
- Deterioration and crumbling of brick piers
- Buckling and separation of the framing and sill under the front door and all along the attached front porch
- Deteriorated, sagging wall covering along the back where the original rear walls and portions of the structure were removed

- Exterior walls bowing outward along the second story to the rear
- Multiple areas of rot, mold, and vegetative growth in the wood siding, window frames, soffits, and moldings

- Separation of brickwork and missing mortar in the uncompleted front steps and porch columns

Staff recommends approval.
