Historic Preservation Design Review

HP-14-14, 21 N. Main St. – Opera House Façade Windows (City)

OPERA HOUSE RENOVATIONS ROOF, CLERESTORY & ASSOCIATED ITEMS

WINDOW REPLACEMENT NARRATIVE:

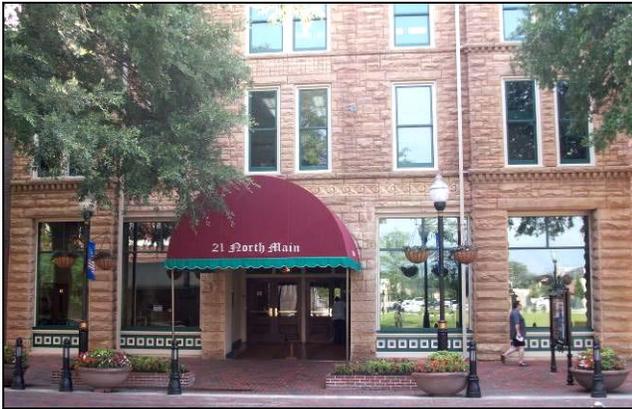
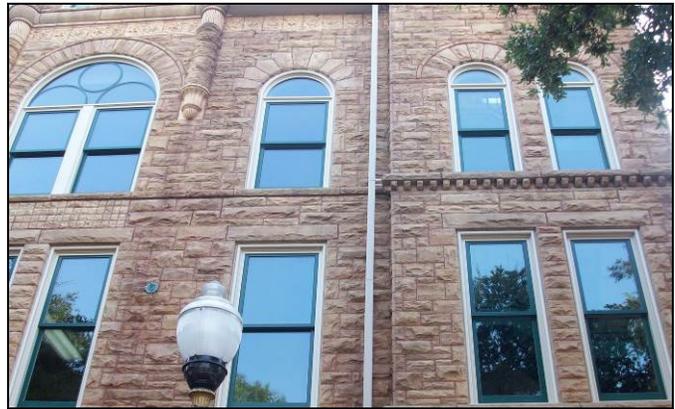
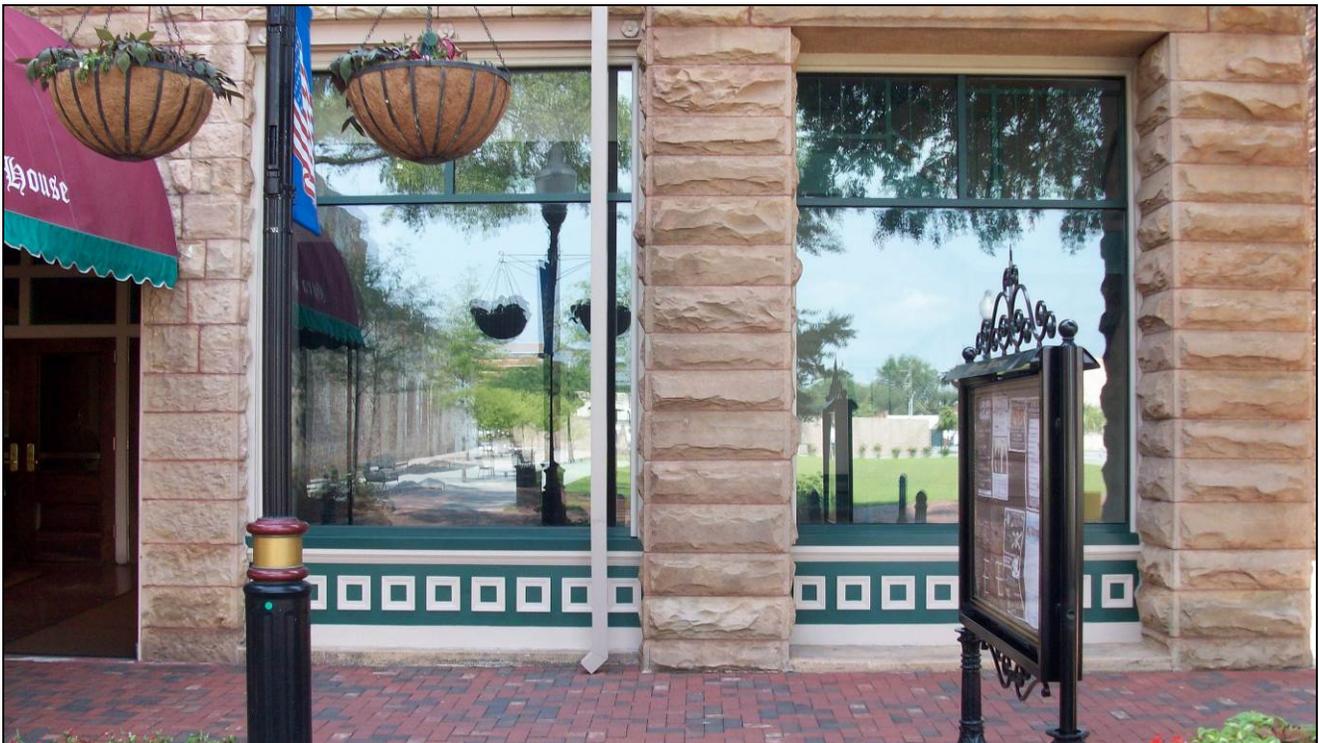
A narrative and photographs were submitted by the architect, Bucky Monroe, as explanation for the necessity of the replacement windows and the replacement design concept (See Attachment 1).

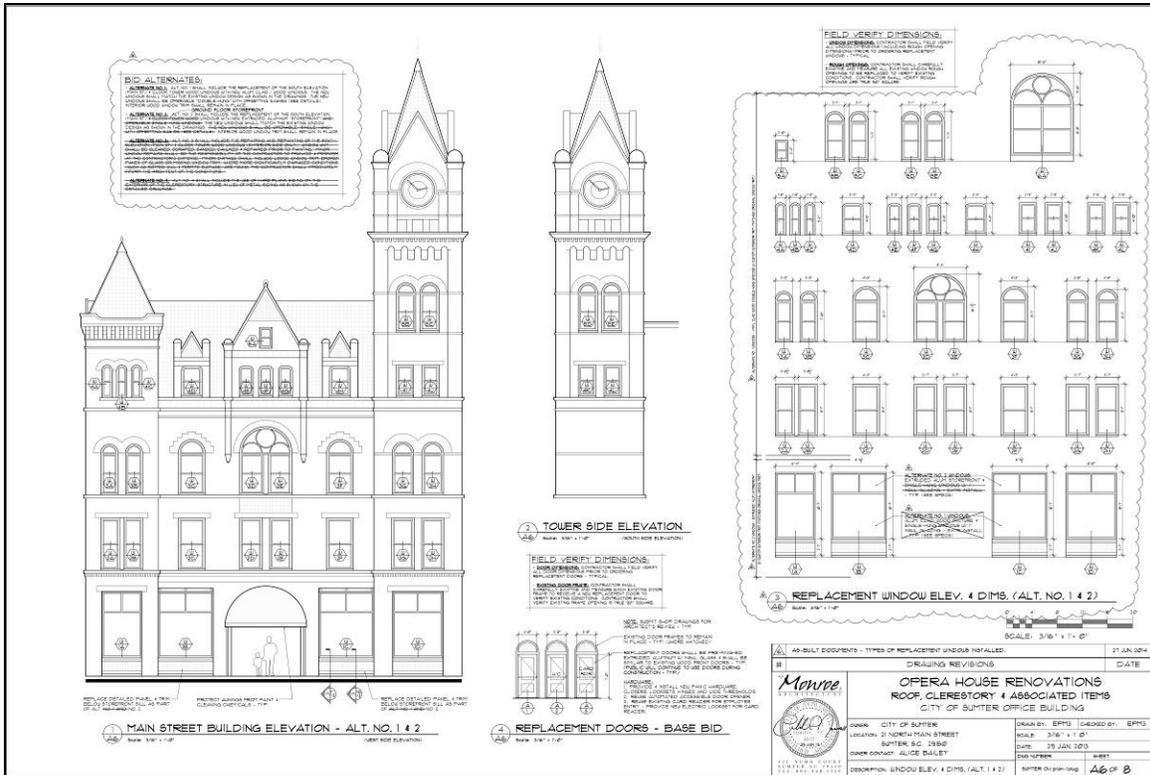
The scope of work, as shown above, included the replacement of 4 first-floor storefront sill windows and 29 upper façade windows of varying sizes, some with rounded transoms.

The replacement windows are wooden clad double-hung and were custom made to match the original windows' configurations.
