REQUEST FOR BIDS
ASBESTOS PROJECT DESIGN, AIR MONITORING & ABATEMENT
ITB #16-25/26
January 9, 2026

Emerald, Inc. was requested to conduct an Asbestos Survey of the vacant commercial structure located at 12 Kelly Ave. in Sumter, S.C., to identify the presence of any asbestos-containing materials (ACM), prior to demolition activities. The inspection was authorized by Mr. John Macloskie, Codes Director, with the City of Sumter. The inspection included identification and assessment of the condition of suspect asbestos-containing materials, either friable or non-friable, on the interior and exterior portions of the structure.

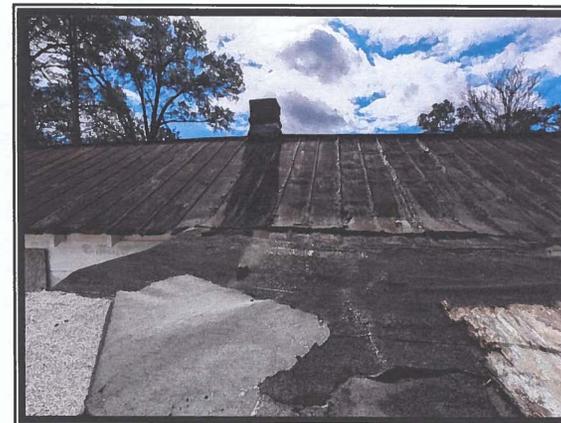
Photo #4
No Asbestos Detected in Roof Shingle Rolls or
Associated Felt Paper

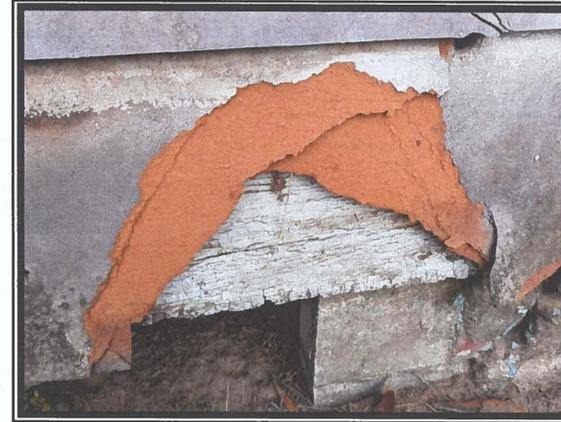
Photo #6
No Asbestos Detected in Cellulose-based
Exterior Siding Material

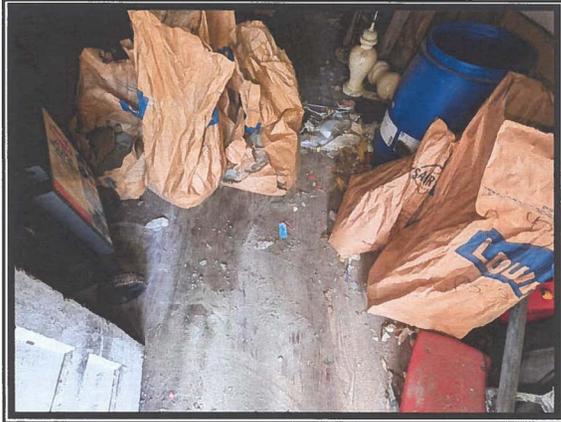
Photo #10
No Asbestos Detected in Cellulose-based
Ceiling and Wall Panels in Room D

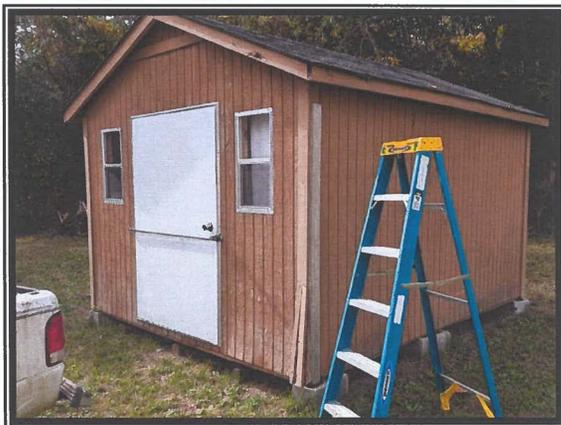
Photo #12
No Asbestos Detected in Roof Shingles of
Storage Shed

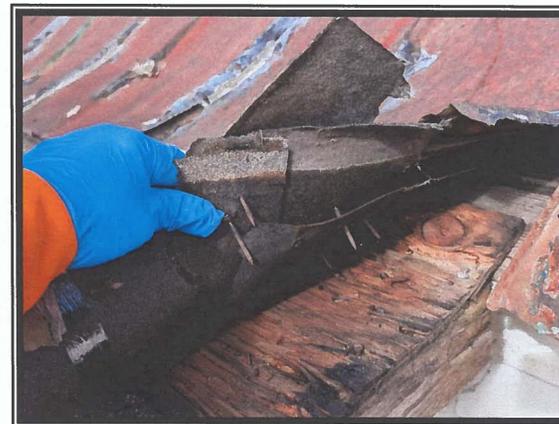
Photo #4
Asbestos Detected at <1% in Felt Paper
Associated with Shingled Roof Area

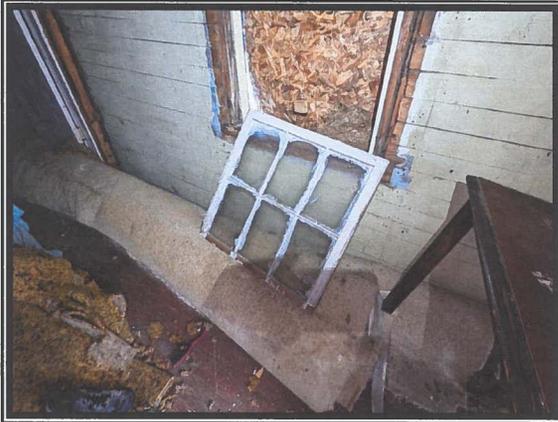
Photo #5
View Depicting Window Unit with Asbestos
Detected in Glaze Material at >1%

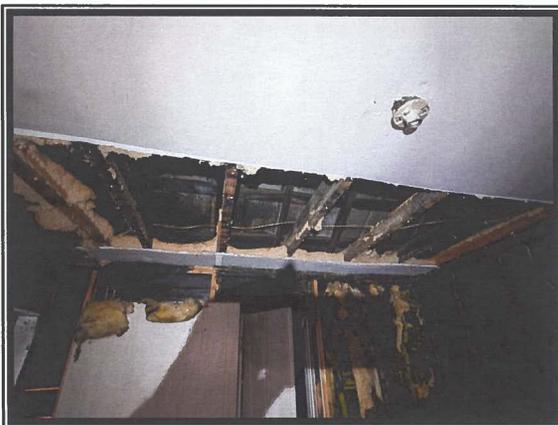
Photo #7
No Asbestos Detected in Sheetrock Ceiling
System

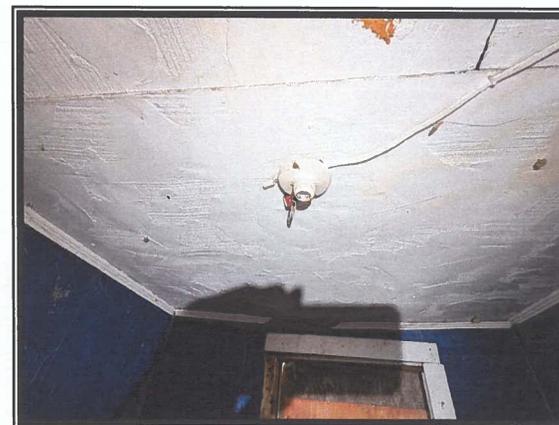
Photo #8
No Asbestos Detected in Cellulose-based
Ceiling and Wall Panels of the Restroom Area

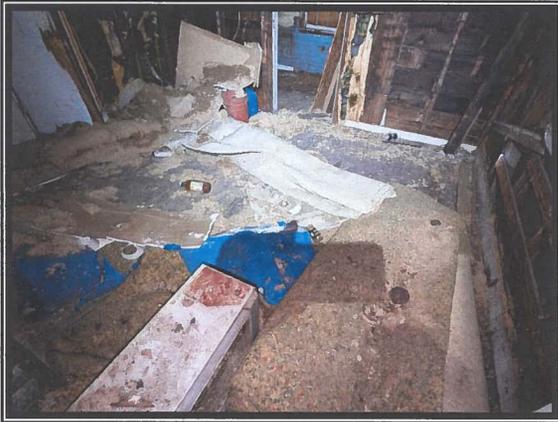
Photo #9
No Asbestos Detected in Carpet Rolls

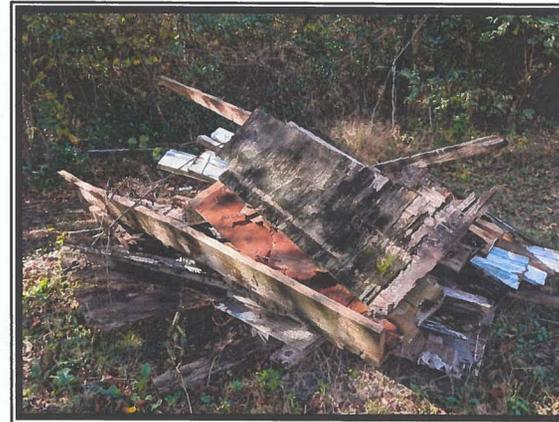
Photo #10
No Suspect Materials Observed in Debris Pile in
the Backyard

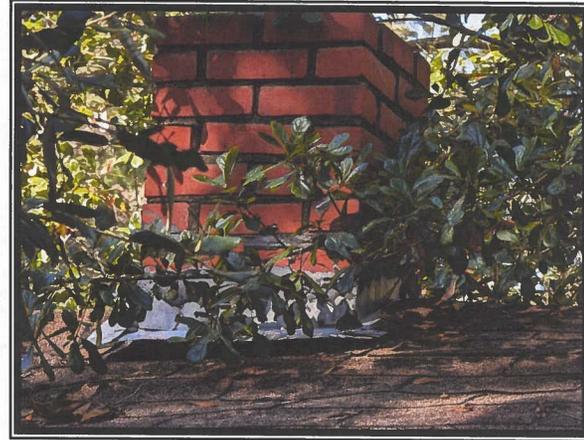
Photo #2
Chimney Flashing Sealant is Presumed to
Contain Asbestos

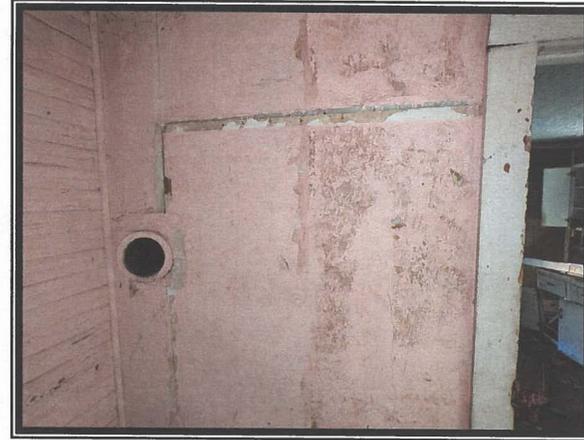
Photo #6
**Asbestos-containing Sheetrock Wall Section
in Room B**

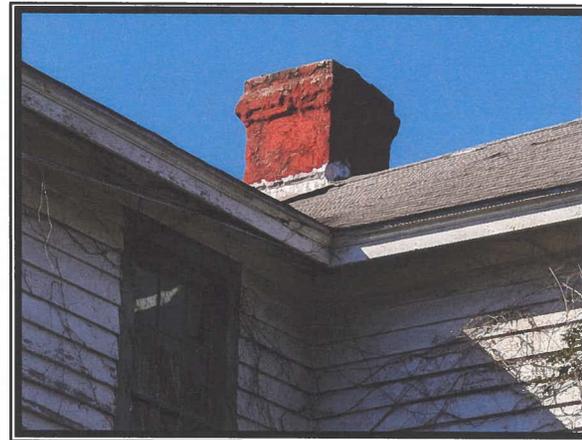
Photo #2
Chimney Flashing Sealant is Presumed to Contain Asbestos

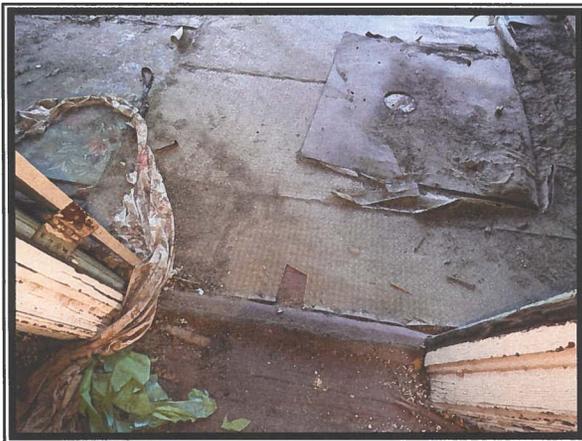
Photo #3
Asbestos Detected at 15% in Tan Sheet Flooring with Red Designs in Room 2C

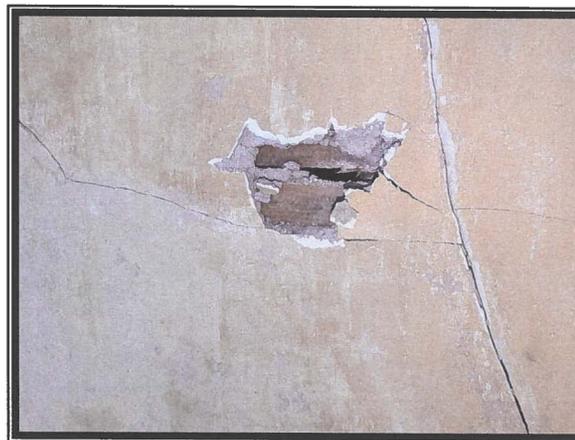
Photo #6
No Asbestos Detected in Plaster Wall System

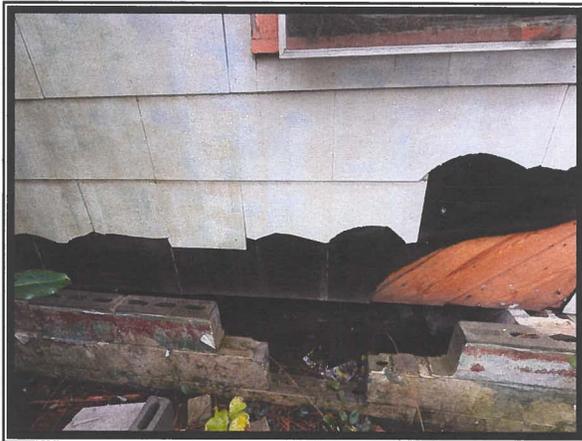
Photo #1
**Asbestos Detected in Transite Siding at 10%;
Asbestos Detected in Wall Felt at <0.1%**

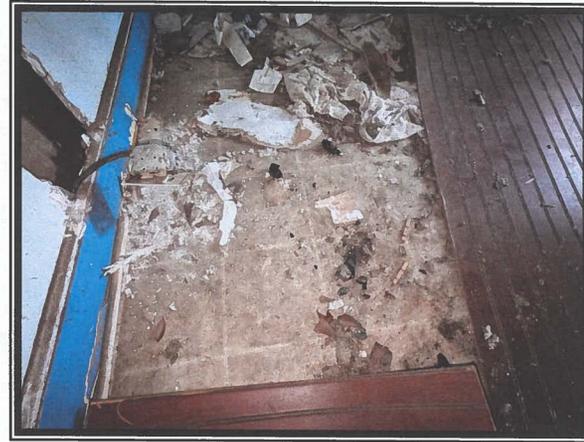
Photo #6
No Asbestos Detected in Sheet Flooring in
Kitchen Area

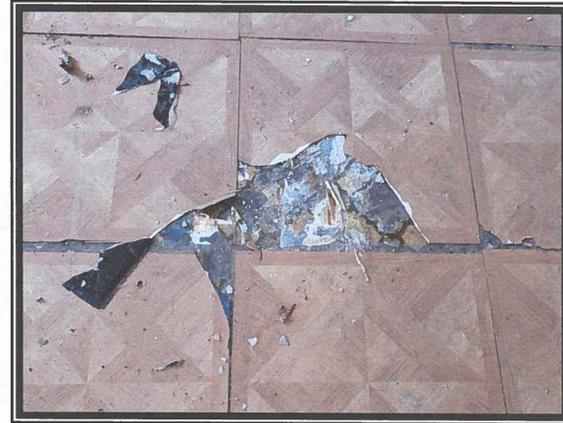
Photo #2
Asbestos-containing, Mottled Green Flooring under Parquet-design Squares in Rm. B

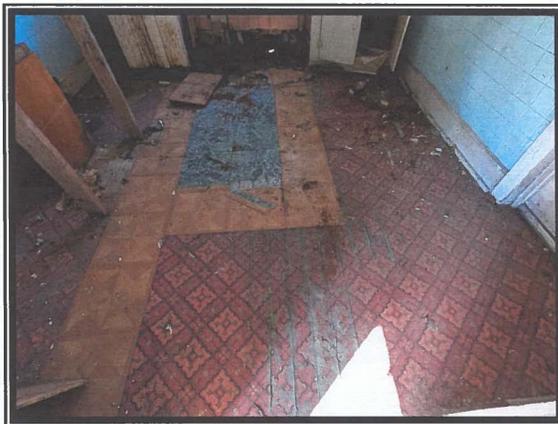
Photo #3
Asbestos-containing, Red-colored Sheet Flooring in Room C

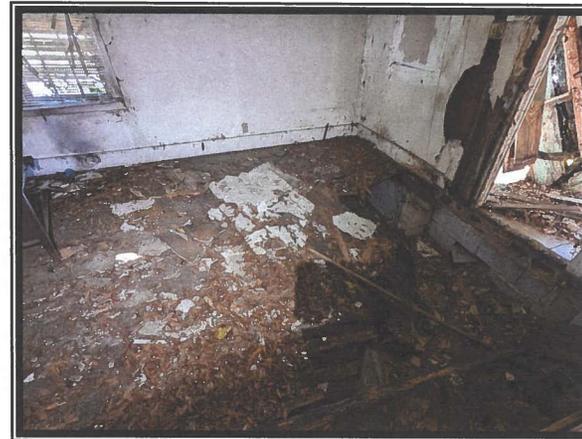
Photo #8
Asbestos-containing, Spray-applied &
Stippled Ceiling Texture Scattered on Floors

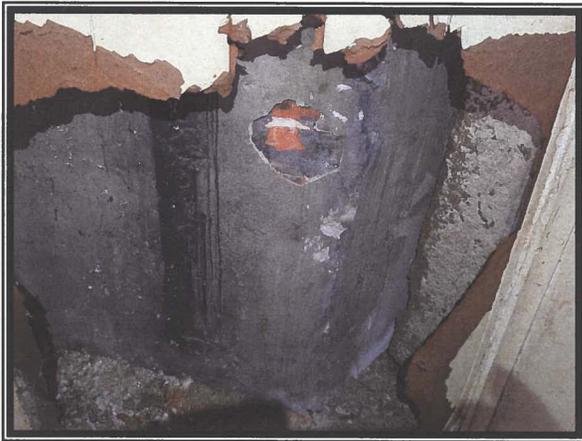
Photo #5
No Asbestos Detected in Surfacing Material on
the Former Chimney Unit

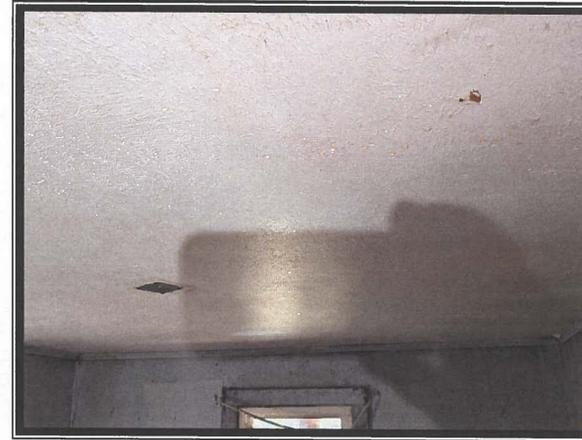
Photo #6
Asbestos Detected at Less than 1% in Stippled
Ceiling Texture of Room H

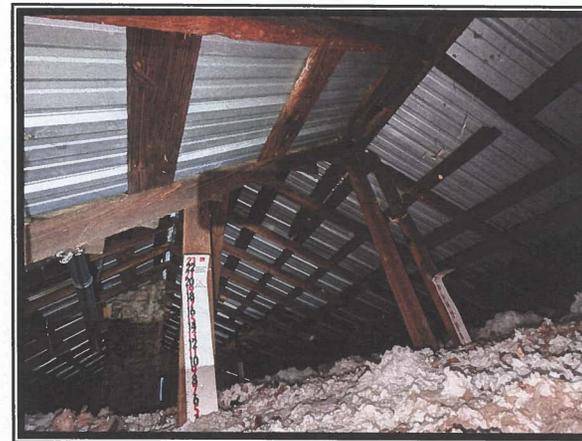
Photo #8
No Suspect Materials Observed in the Wooden,
A-framed Attic Area

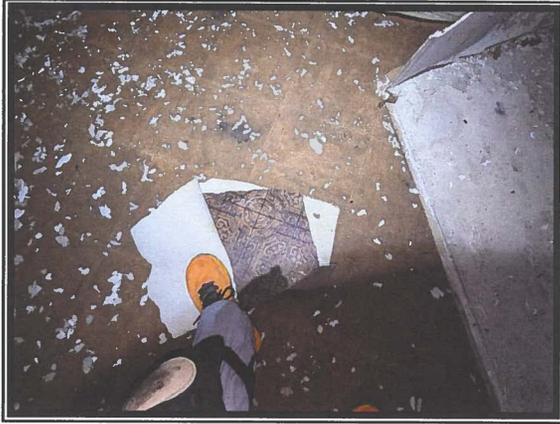
Photo #6
Asbestos Detected at 30% in Bottom-layer,
Yellowish Tan Sheet Flooring in Room F

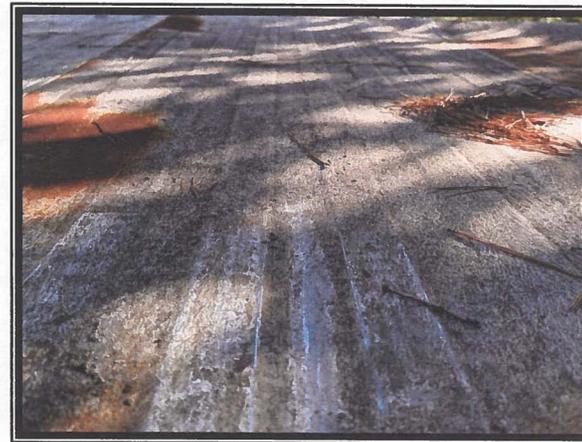
Photo #2
No Asbestos Detected in Metal Roof Sealant Material

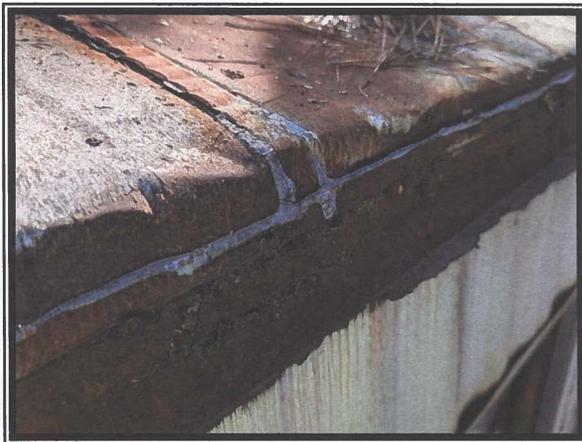
Photo #3
No Asbestos Detected in Roof Seam/Roof Edge Flashing Sealant

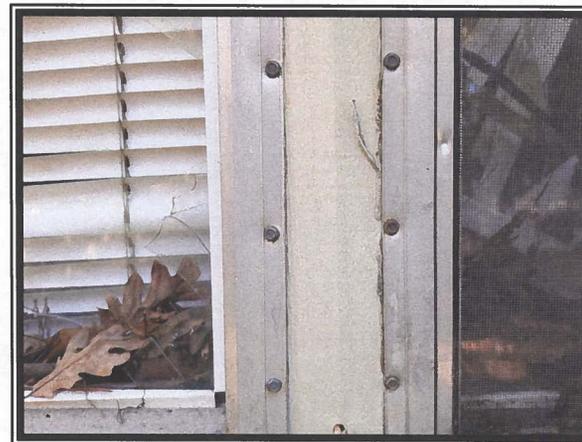
Description	Location	Category (F/NF)	Approx. SF/LF
Window Frame Caulk	Exterior Window Frame Seams	NF – Cat. I – Good Condition	120 LF

Photo #4
Asbestos Detected at 4% in Window Frame Caulk

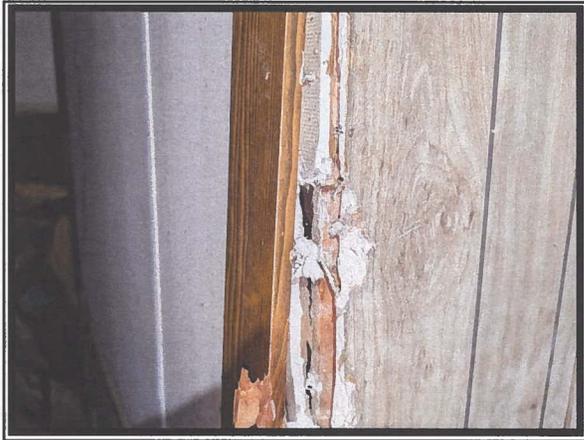
Photo #5
No Asbestos Detected in Wallboard Materials

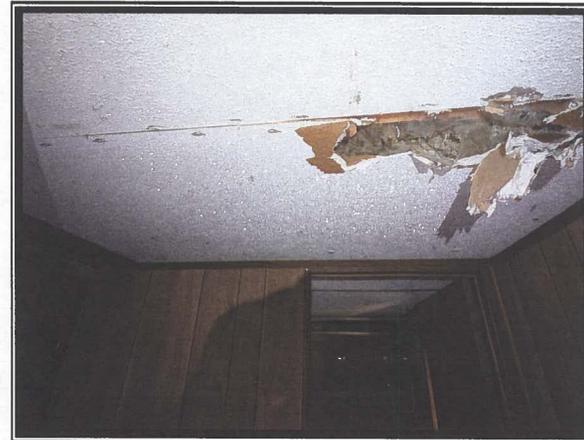
Photo #6
No Asbestos Detected in Ceiling Gypsum with
Textured Surface Material

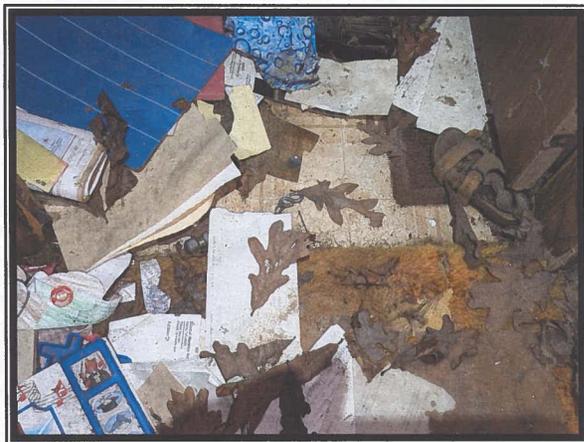
Photo #7
No Asbestos Detected in Sheet Flooring or
Carpet Materials

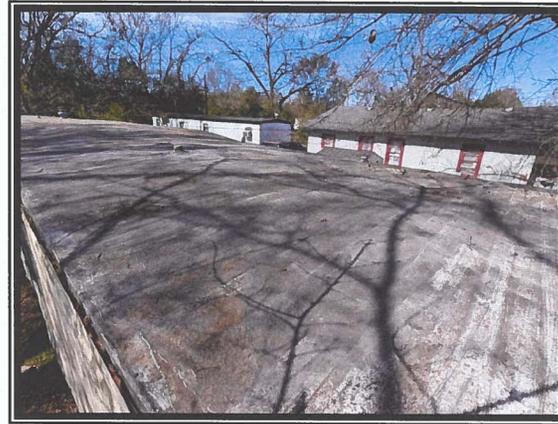
Photo #2
Asbestos Detected at 1.7% in Silver Roof Sealant Material

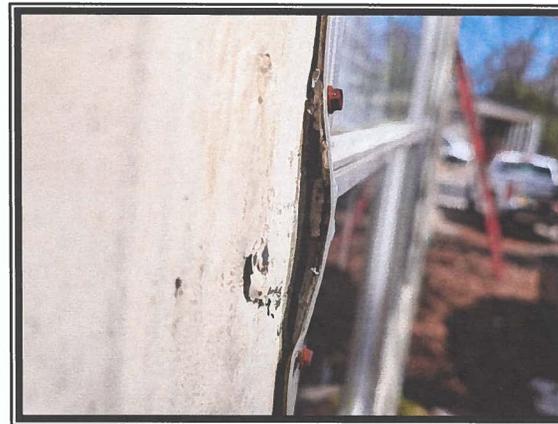
Photo #4
No Asbestos Detected in Window/Door Frame Caulk Material

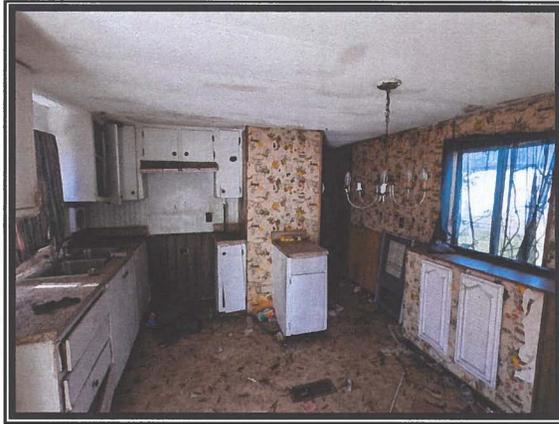
Photo #5
No Asbestos Detected in Wallpaper Layers

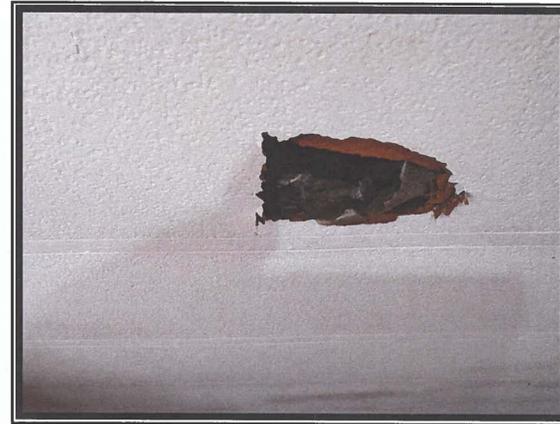
Photo #6
No Asbestos Detected in Fiberboard Ceiling Panels

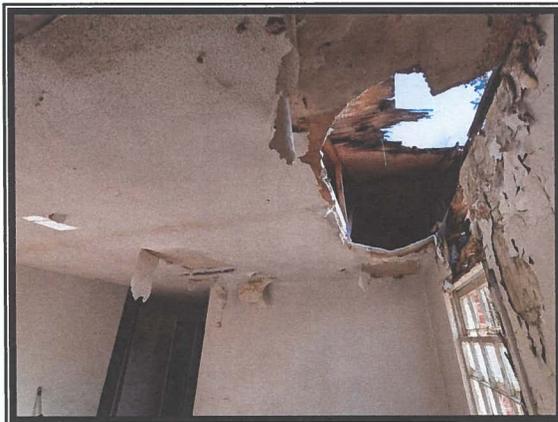
Photo #3
Asbestos Detected in Sheetrock System at
3% & in Spray-applied Ceiling Texture at 2%

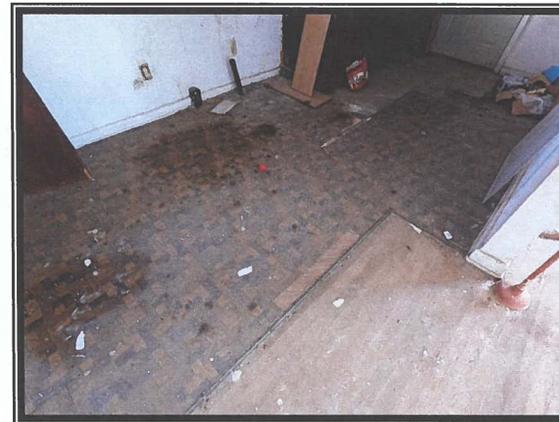
Photo #4
No Asbestos Detected in Flooring Squares

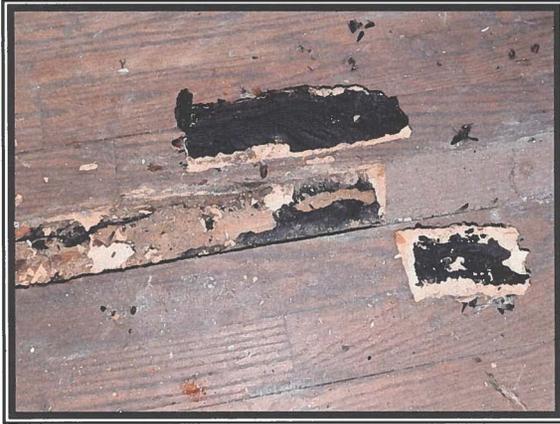
Photo #5
No Asbestos Detected in Flooring Vapor Felt
Material

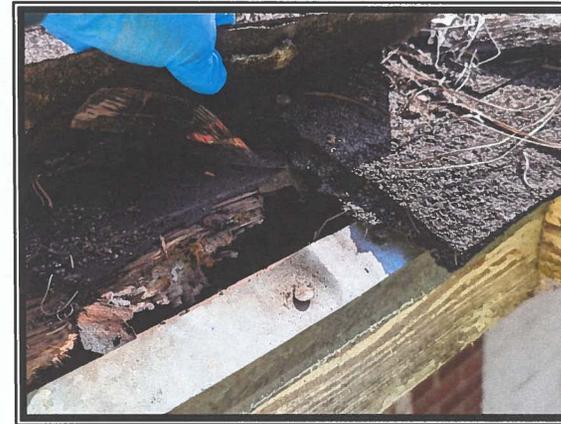
Photo #8
No Asbestos Detected in Roofing Shingles or
Associated Felt Paper
